# Fire Station at 1476 West Street

City of Attleboro  
ADA Transition Plan

April 2021

Institute for Human Centered Design

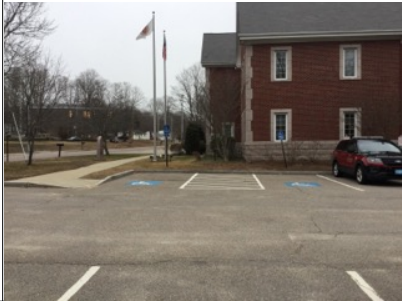
ID	Location	Floor	Room	Element	Type	Photo	Issues	Current Measure	Recommendations	Quantity	Price	Cost Estimation
<b>Approach and Entrance</b>												
<b>Off-Street Parking Lot or Garage</b>												
1	Accessible Parking	Ext.		Off-Street Parking Lot or Garage	N/A

Total # of parking Total # of designated accessible parking spaces Total # of designated van accessible spaces Sign bottom < 60" above finished grade	25 1 1 55"	Locate the International Symbol of Accessibility (ISA) identification sign at the car accessible parking space so it is 60" above the ground measured to the bottom of the sign.	1	Labor	\$0
<b>Exterior Stair</b>												
2	Exit Stair	Ext.		Exterior Stair	N/A

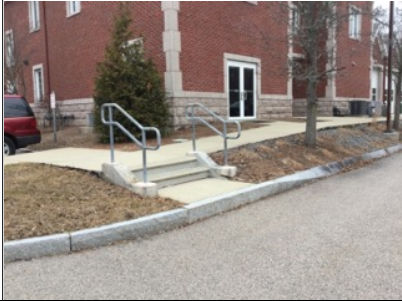
Handrail height < 34" or > 38"	42"	Handrails are slightly higher above the ground than required but usable.	1	-	\$0
<b>Emergency Exit</b>												
3	Main Entrance	1		Emergency Exit	N/A

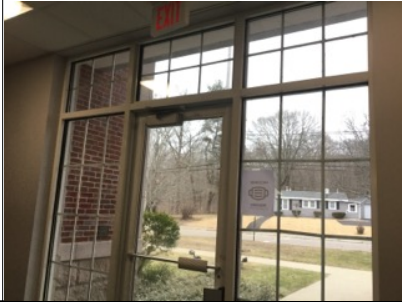
Tactile sign not provided at exit	-	Provide tactile exit signs with raised characters and braille at exit doors. Mount signs between 48"- 60" above the finished floor located on the latch side of the door. If the exit sign is replaced with a new illuminated exit sign, provide an illuminated International Symbol of Accessibility (ISA).	1	232	\$232

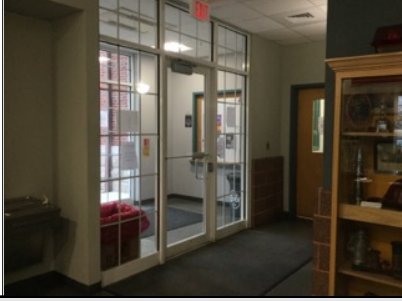
4	Main Entrance	1		Emergency Exit	N/A

Tactile sign not provided at exit Illuminated Int. Symbol of Acc. not provided (MAAB)		Provide tactile exit signs with raised characters and braille at exit doors. Mount signs between 48"- 60" above the finished floor located on the latch side of the door. If the exit sign is replaced with a new illuminated exit sign, provide an illuminated International Symbol of Accessibility (ISA).	1	232	\$232
<b>Access to Goods and Services</b>

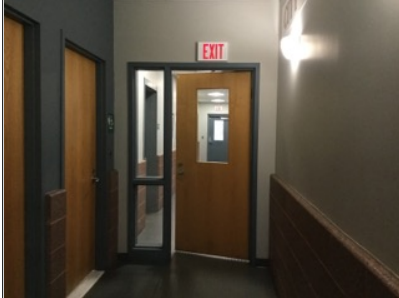
ID	Location	Floor	Room	Element	Type	Photo	Issues	Current Measure	Recommendations	Quantity	Price	Cost Estimation
<b>Means of Egress</b>												
5	To Meeting Room	1		Means of Egress	N/A

Tactile exit sign not provided	-	Ensure tactile exit signs with raised characters and braille are provided at exit doors. Mount signs between 48"- 60" above the finished floor located on the latch side of the door.	1	232	\$232
6	Exit in Hallway Adjacent to Meeting Room	1		Means of Egress	N/A

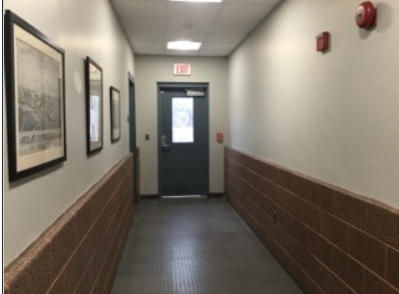
Tactile exit sign not provided	-	Ensure tactile exit signs with raised characters and braille are provided at exit doors. Mount signs between 48"- 60" above the finished floor located on the latch side of the door.	1	232	\$232
7	Leads to Garage	1		Means of Egress	N/A

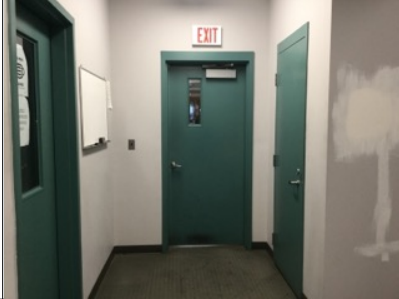
Tactile exit sign not provided	-	Ensure tactile exit signs with raised characters and braille are provided at exit doors. Mount signs between 48"- 60" above the finished floor located on the latch side of the door.	1	232	\$232

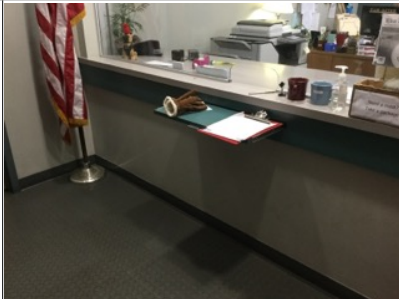
<b>Interior Access Route</b>												
8	Reception	1		Interior Access Route	N/A

Obstructed by protruding objects	-	Provide a cane-detectable barrier 27" max. above the finished floor at that accessible service counter.	1	306	\$306
<b>Doors, Doorways, &amp; Gates</b>												
9	Main Entrance	1		Doors, Doorways, & Gates	Circulation

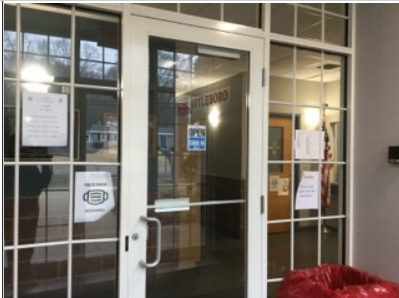
Door requires > 5 lbs. of force to open	15 lbs.	Adjust closers so doors do not require more than 5 pounds of force to open.	1	Labor	\$0

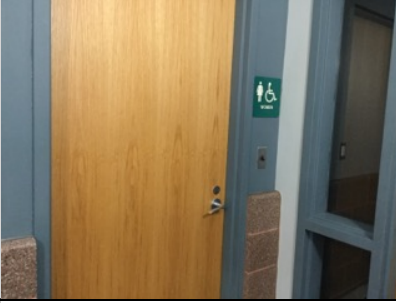
ID	Location	Floor	Room	Element	Type	Photo	Issues	Current Measure	Recommendations	Quantity	Price	Cost Estimation
10	Women's Toilet Room	1		Doors, Doorways, & Gates	Toilet Room

Door requires > 5 lbs. of force to open	11 lbs.	Adjust closers so doors do not require more than 5 pounds of force to open.	1	Labor	\$0
11	To Meeting Room	1		Doors, Doorways, & Gates	Emergency Egress

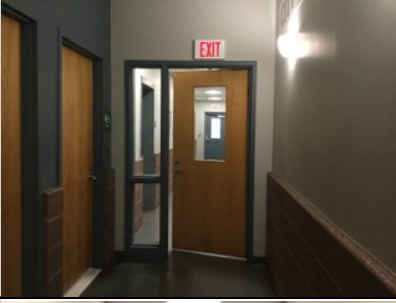
Door requires > 5 lbs. of force to open	11 lbs.	Adjust closers so doors do not require more than 5 pounds of force to open.	1	Labor	\$0
12	Exit in Hallway Adjacent to Meeting Room	1		Doors, Doorways, & Gates	Emergency Egress

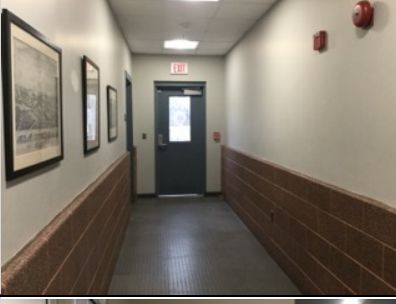
Door requires > 5 lbs. of force to open	15 lbs.	Adjust closers so doors do not require more than 5 pounds of force to open.	1	Labor	\$0
13	Leads to Garage	1		Doors, Doorways, & Gates	Circulation

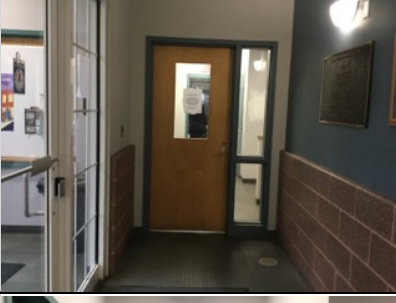
Door requires > 5 lbs. of force to open	11 lbs.	Adjust closers so doors do not require more than 5 pounds of force to open.	1	Labor	\$0

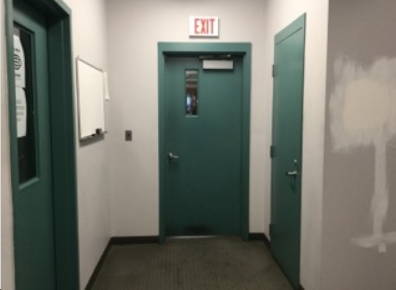
14	Leads to Garage	1		Doors, Doorways, & Gates	Emergency Egress

Door requires > 5 lbs. of force to open	11 lbs.	Adjust closers so doors do not require more than 5 pounds of force to open.	1	Labor	\$0

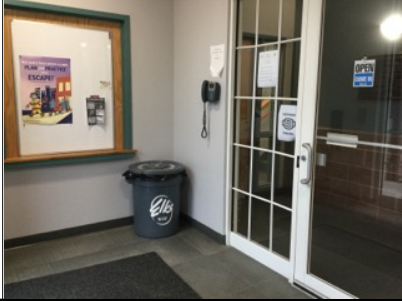
ID	Location	Floor	Room	Element	Type	Photo	Issues	Current Measure	Recommendations	Quantity	Price	Cost Estimation
<b>Operable Parts</b>												
15	Main Entrance	1		Operable Parts	Other

Reach < 15" or > 48"(forward/side approach)	57"	Relocate phone so that controls are between 15"- 48" above the finished floor. Monitor location of trash receptacle ensuring clear floor space is maintained at the phone.	1	256	\$256
<b>Assembly Area</b>												
16	Meeting Room	1		Assembly Area	N/A

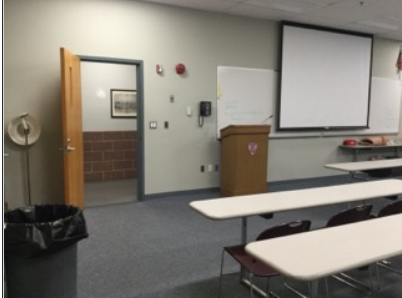
Accessibility issues include lack of an assistive listening system in the meeting room.

Assistive listening devices not provided	-	If audible communication is integral to the use of the space, provide an assistive listening system.	1	1214	\$1214
<b>Toilet &amp; Bathing Rooms</b>												
<b>Lavatory</b>												
17	Men's Toilet Room	1		Lavatory	N/A

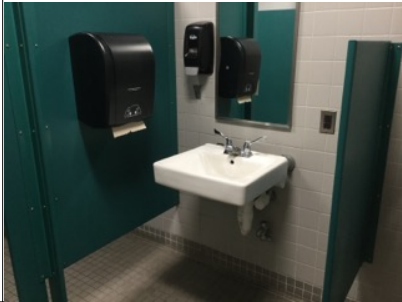
Clear floor space not provided at lavatory	-	Provide at least one lavatory with a 30" min. by 48" min. clear floor space positioned for a forward approach. (Relocate paper towel dispenser out of clear floor space at accessible lavatory. At present, paper towel dispenser is also a protruding object.)	1	353	\$353

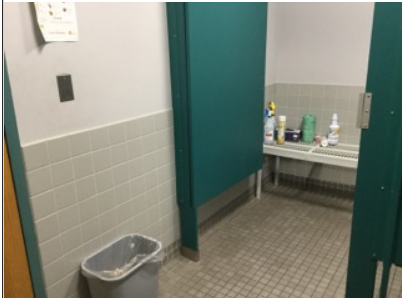
<b>Toilet Compartment</b>												
18	Men's Toilet Room	1		Toilet Compartment	Accessible Compartment

Door has malfunctioning self-closing hinge	-	Repair hinge.	1	Labor	\$0

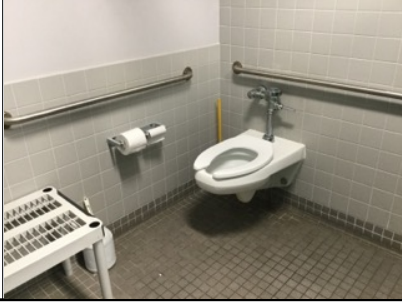
ID	Location	Floor	Room	Element	Type	Photo	Issues	Current Measure	Recommendations	Quantity	Price	Cost Estimation
19	Men's Toilet Room	1		Toilet Compartment	Accessible Compartment

Clearance at toilet < 72" clear depth (MAAB)	-	Provide a wheelchair accessible compartment that is 60" wide and 72" deep. (Relocate stored items out of clear floor space at toilet.)	1	Labor	\$0
<b>Urinal</b>												
20	Men's Toilet Room	1		Urinal	N/A

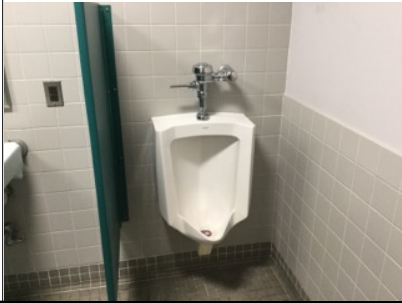
Rim > 17" high	18.25"	Provide at least one urinal with the rim no higher than 17" above the finished floor.	1	3248	\$3248
<b>Dispensers</b>												
21	Women's Toilet Room	1		Dispensers	Tampon Dispenser

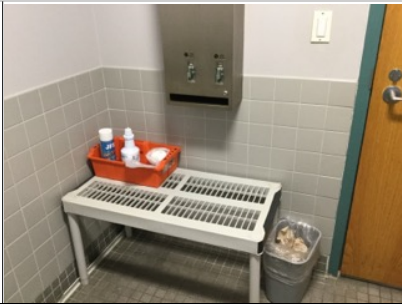
Clear floor space not provided at accessory	-	Provide a 30" min. by 48" min. clear floor space at dispenser. (Relocate stored items and be sure not to obstruct the required clear floor space at the toilet.)	1	Labor	\$0
<b>Additional Access</b>

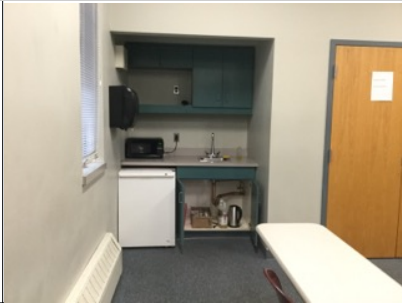
<b>Sink</b>												
22	Meeting Room	1		Sink	Kitchenette

Accessibility issues include lack of knee and toe clearance and exposed plumbing at the sink in the meeting room.

Toe and knee clearances not provided Exposed plumbing underneath sink	- -	Ensure there is a 27" knee clearance positioned for a forward approach. Insulate or otherwise configure pipes at sink.	1	1778	\$1778
<b>Best Practice</b>

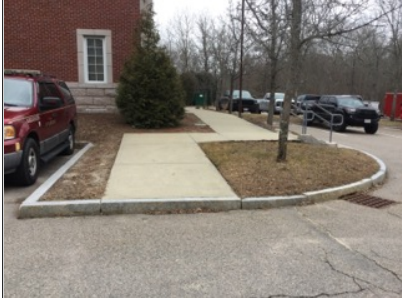
ID	Location	Floor	Room	Element	Type	Photo	Issues	Current Measure	Recommendations	Quantity	Price	Cost Estimation
<b>Walkway</b>												
23	Exit Path End	Ext.		Walkway	N/A

Recommend installing a curb cut at this location.	1	-	\$0
