Recycling Facility

City of Attleboro ADA Transition Plan

April 2021

City of Attleboro Recycling Facility

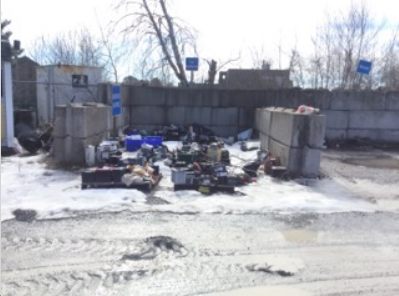
ID	Location	Floor	Room	Element	Type	Photo	Issues	Current Measure	Recommendations	Quantity	Price	Cost Estimation
Approach and Entrance												
Exterior Access Route												
1	Car Batteries	Ext.		Exterior Access Route	Exterior

Route not maintained in operable working condition	-	Ensure the accessible route is maintained in operable working condition. Ensure that snow is removed at each recycling area.	1	Labor	\$0
2	Tire Disposal Area	Ext.		Exterior Access Route	Exterior

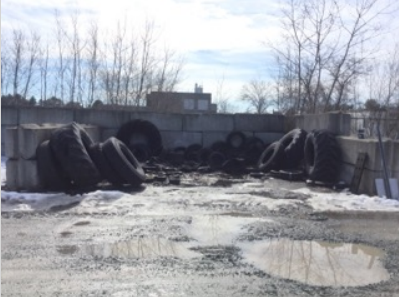
Route not maintained in operable working condition	-	Ensure the accessible route is maintained in operable working condition. Ensure that snow is removed at each recycling area.	1	Labor	\$0
3	Yellow and Green Recycling Bin	Ext.		Exterior Access Route	Exterior

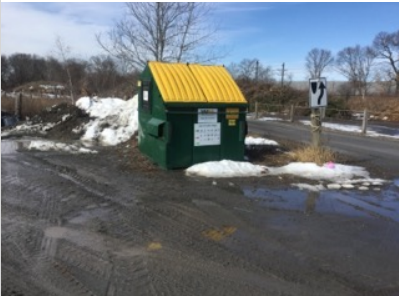
Route not maintained in operable working condition	-	Ensure the accessible route is maintained in operable working condition. Ensure that snow is removed at each recycling area.	1	Labor	\$0

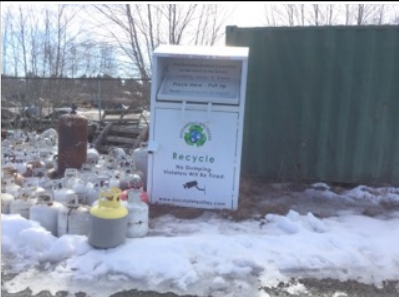
4	Clothing Drop-Off Bin and Propane Tank Recycling Area	Ext.		Exterior Access Route	Walkway

Route not maintained in operable working condition		Ensure the accessible route is maintained in operable working condition. Ensure that snow is removed at each recycling area.	2	Labor	\$0
5	Light Bulb Recycling	Ext.		Exterior Access Route	185

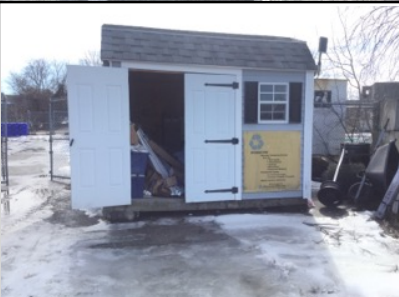
Route not maintained in operable working condition		Ensure the accessible route is maintained in operable working condition. Ensure that snow is removed at each recycling area.	1	Labor	\$0

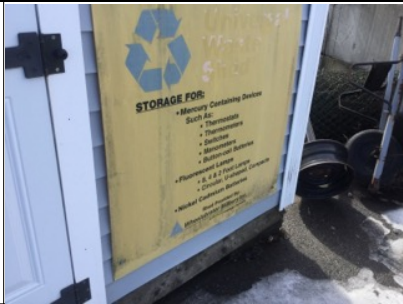
ID	Location	Floor	Room	Element	Type	Photo	Issues	Current Measure	Recommendations	Quantity	Price	Cost Estimation
11	Light Bulb Recycling	Ext.		Signage	Informational

Visual characters < 40" above ground	-	Mount visual sign so that the baseline of the lowest character is 40" min. above the ground.	1	Labor	\$0
12	Green and Yellow Recycling Bin	Ext.		Signage	Informational

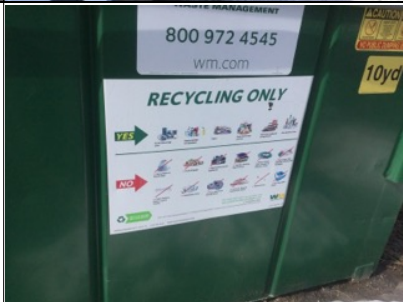
Visual characters < 40" above ground	25"	Mount visual sign so that the baseline of the lowest character is 40" min. above the ground.	1	Labor	\$0
Operable Parts												
13	Book Dropbox	Ext.		Operable Parts	Other

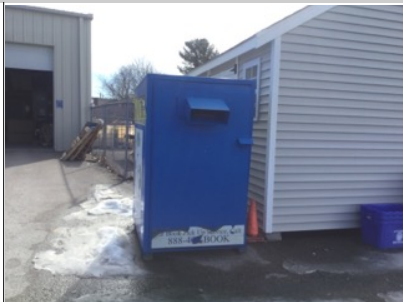
Reach < 15" or > 48"(forward/side approach)	57.5"	Have staff provide assistance at the book dropbox as needed.	1	-	\$0
14	Clothing Drop-Off	Ext.		Operable Parts	Trash/Recycling

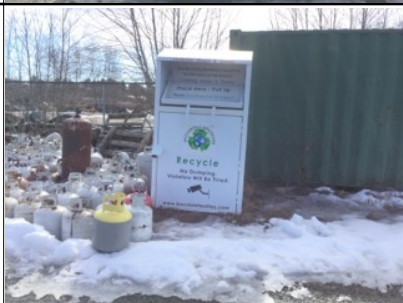
Reach < 15" or > 48"(forward/side approach)	53.5"	Have staff provide assistance at the clothing drop-off as needed.	1	-	\$0
Best Practice

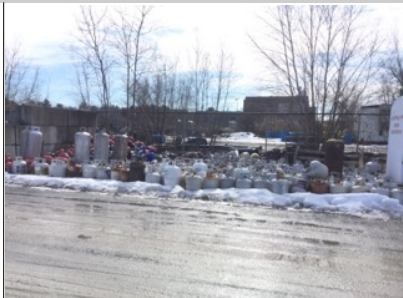
15	Tire Disposal Area and Propane Tank Disposal Area	Ext.			-

-	Recommend providing visual signs in the tire disposal area and propane tank disposal area.	2	-	\$0

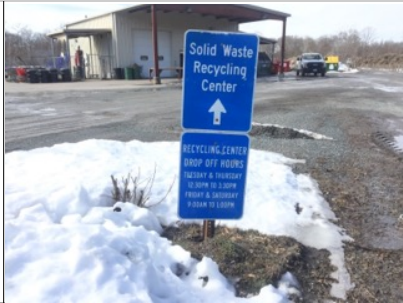
ID	Location	Floor	Room	Element	Type	Photo	Issues	Current Measure	Recommendations	Quantity	Price	Cost Estimation
16	Entrance	Ext.			-

-	Recommend providing instructions on the sign at the entrance describing how visitors with disabilities can notify staff that they require assistance. Further recommend providing information on the recycling facility web site about the best way for visitors with disabilities to request assistance from staff so that visitors can plan before they go.	1	-	\$0
