YMCA Sanford Street Municipal Parking Lot

City of Attleboro
ADA Transition Plan

March 2021

Institute for Human Centered Design

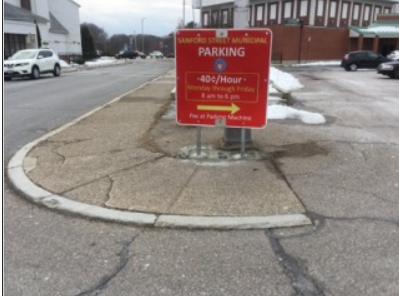
ID	Location	Floor	Room	Element	Type	Photo	Issues	Current Measure	Recommendations	Quantity	Price	Cost Estimation
Approach and Entrance												
Exterior Access Route												
1	Front Sidewalk Opposite to Front Accessible Parking	Ext.		Exterior Access Route	Walkway

Level changes > 1/4"	.5"	Alter change in level to be 1/4" high max. (Cost based on an asphalt patch to reduce lip between lot and walkway.)	1	160	\$160
2	Sidewalk at Main Entry	Ext.		Exterior Access Route	Sidewalk

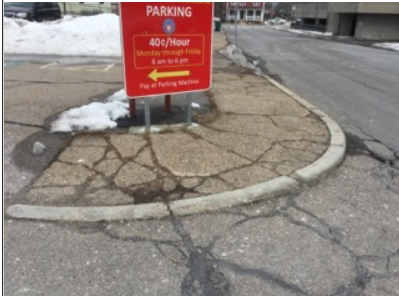
Accessible route not provided	-	Ensure an accessible route is provided. Repair deteriorated sidewalk. (Cost base on concrete to repair sidewalk.)	1	1500	\$1500
3	Sidewalk at Main Entry	Ext.		Exterior Access Route	Sidewalk

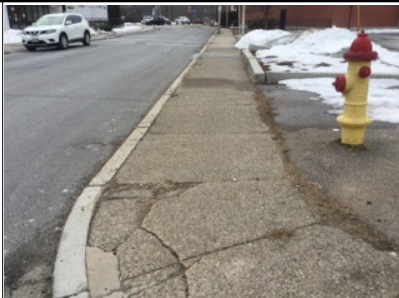
Accessible route not provided	-	Ensure an accessible route is provided. (Cost based on concrete to repair sidewalk.)	1	600	\$600
Off-Street Parking Lot or Garage												
4	Accessible Parking at Northwest Corner of Lot	Ext.		Off-Street Parking Lot or Garage	N/A

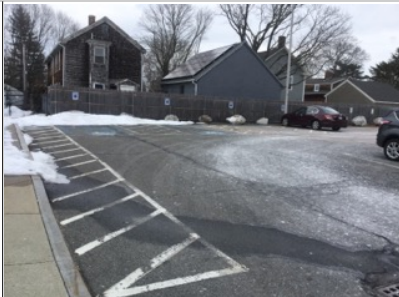
Total # of parking Total # of designated accessible parking spaces Total # of designated van accessible spaces Sign does not have the designation "Van Accessible" Sign bottom < 60" above finished grade	156 3 1 - 41.5"	Add the designation "Van Accessible" to the sign located at the van accessible space. Locate each parking sign with the bottom of the sign 60" min. above the ground.	1	500	\$500

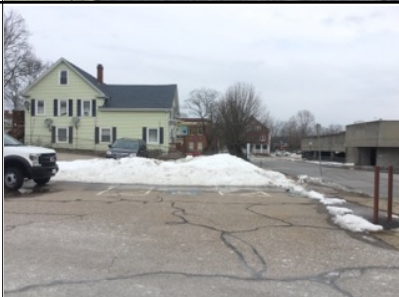
5	Accessible Parking Southeast Corner of Lot	Ext.		Off-Street Parking Lot or Garage	N/A

Total # of designated accessible parking spaces Sign not provided	2 -	Provide a sign with the International Symbol of Accessibility (ISA) with the bottom of the sign 60" min. above the ground and the top 96" max. above the ground.	1	500	\$500

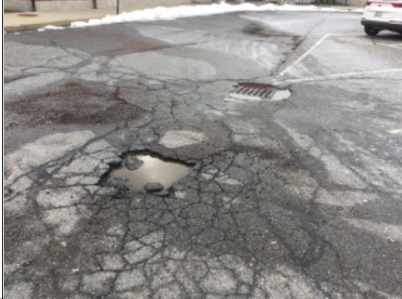
ID	Location	Floor	Room	Element	Type	Photo	Issues	Current Measure	Recommendations	Quantity	Price	Cost Estimation
Best Practice												
Parking Lot												
6	Parking Lot Towards YMCA Building	Ext.		Parking Lot	N/A

Recommend resurfacing lot where asphalt is significantly deteriorated.	1	-	\$0
