# Sanford Street Municipal Parking Garage

## City of Attleboro ADA Transition Plan

March 2021

Institute for Human Centered Design

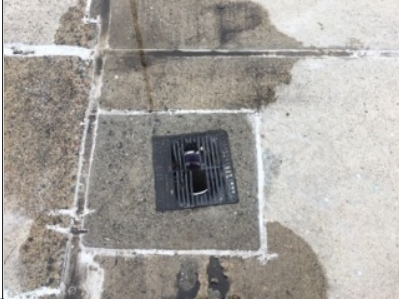
ID	Location	Floor	Room	Element	Type	Photo	Issues	Current Measure	Recommendations	Quantity	Price	Cost Estimation
<b>Approach and Entrance</b>												
<b>Exterior Access Route</b>												
1	Upper Level Parking by Exit	2		Exterior Access Route	Exterior

Surface openings > 1/2"	6"	Replace or reposition drainage grate.	1	100	\$100
2	Rear of the Buidling by Academy Street	Ext.		Exterior Access Route	Exterior

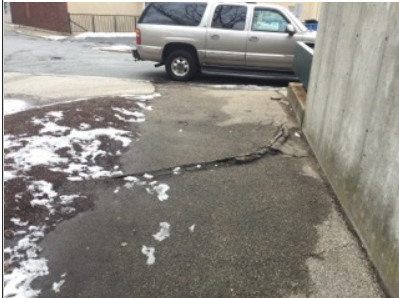
Level changes > 1/4"	3"	Alter change in level to be 1/4" high max.	1	256	\$256
3	Exit Near Condo Spaces and One Accessible Parking Space	1		Exterior Access Route	Walkway

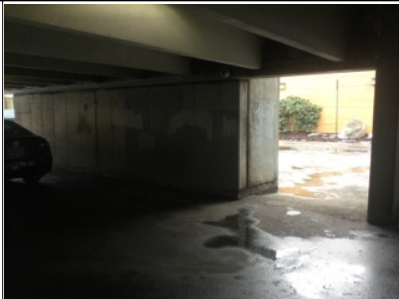
Does not prevent accumulation of water	-	Ensure that water does not collect along the exit route.	1	Labor	\$0
4	Near Exterior Stair From Upper Level Parking	Ext.		Exterior Access Route	Exterior

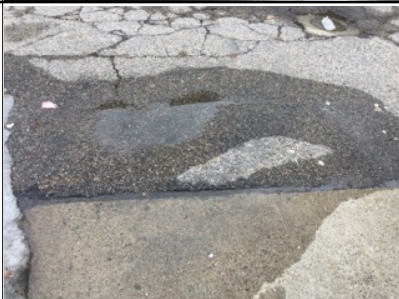
Does not prevent accumulation of water	.5"	Repair surface.	1	256	\$256
5	Path on Right of Main Entrance	Ext.		Exterior Access Route

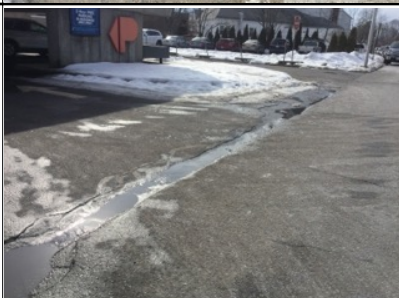
Does not prevent accumulation of water	-	Repair surface.	1	768	\$768

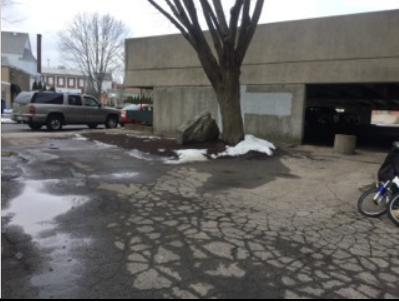
ID	Location	Floor	Room	Element	Type	Photo	Issues	Current Measure	Recommendations	Quantity	Price	Cost Estimation
6	Exit Near Accessible Spaces to Academy Street	Ext.		Exterior Access Route	Walkway

Does not prevent accumulation of water Route not maintained in operable working condition	- -	Repair surface. Ensure the accessible route is maintained in operable working condition. (Cost estimate for repairing 20' long by 4' wide area of asphalt).	1	800	\$800
7	Rear Exit by Condo Parking and One Accessible Space	Ext.		Exterior Access Route	Exterior

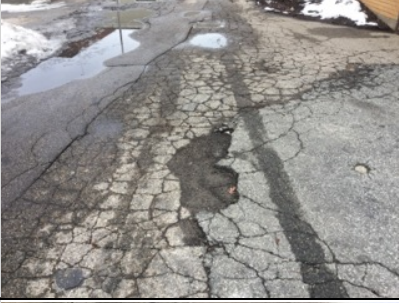
Does not prevent accumulation of water Route not maintained in operable working condition	- -	Repair surface. Ensure the accessible route is maintained in operable working condition. (Cost estimate for repairing 10' by 4' wide asphalt route.)	1	400	\$400
8	Rear Exit by Condo Parking and One Accessible Space by Bank Street	Ext.		Exterior Access Route	Exterior

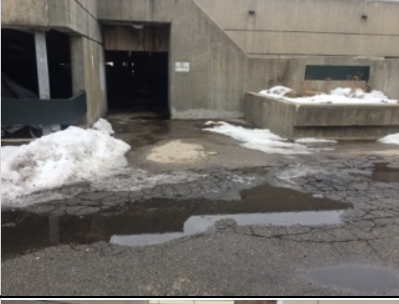
Does not prevent accumulation of water Route not maintained in operable working condition	- -	Repair surface. Ensure the accessible route is maintained in operable working condition. (Cost estimate for repairing 10' by 4' wide asphalt route.)	1	400	\$400

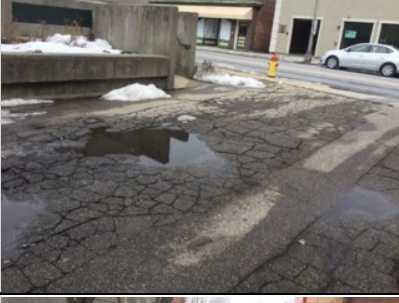
9	Rear of Garage by Bank Street	Ext.		Exterior Access Route	Exterior

Does not prevent accumulation of water Route not maintained in operable working condition	- -	Repair surface. Ensure the accessible route is maintained in operable working condition. (Cost estimate for repairing 30' by 4' wide asphalt route.)	1	1200	\$1200
10	Rear Side of the Building Looking Toward Bank Street	Ext.		Exterior Access Route	Exterior

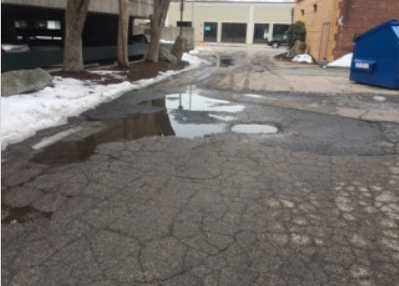
Does not prevent accumulation of water Route not maintained in operable working condition	- -	Repair surface. Ensure the accessible route is maintained in operable working condition. (Cost estimate for repairing 20' by 4' wide asphalt route.)	1	800	\$800

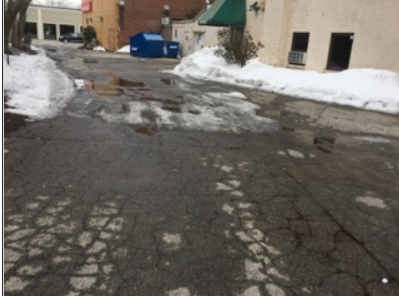
ID	Location	Floor	Room	Element	Type	Photo	Issues	Current Measure	Recommendations	Quantity	Price	Cost Estimation
11	Walkway on Rear Side of Garage	Ext.		Exterior Access Route	Exterior

Does not prevent accumulation of water Route not maintained in operable working condition	- -	Repair surface. Ensure the accessible route is maintained in operable working condition. (Cost estimate for repairing 10' by 4' wide asphalt route.)	1	400	\$400
12	Rear of the Buidling by Academy Street	Ext.		Exterior Access Route	Exterior

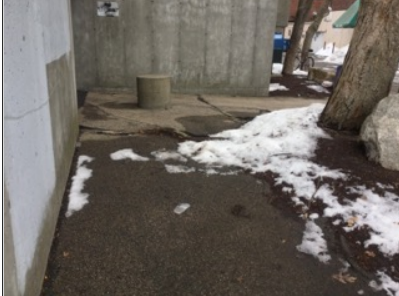
Route not maintained in operable working condition	-	Ensure the accessible route is maintained in operable working condition.	1	256	\$256
13	Rear of the Buidling by Academy Street	Ext.		Exterior Access Route	Exterior

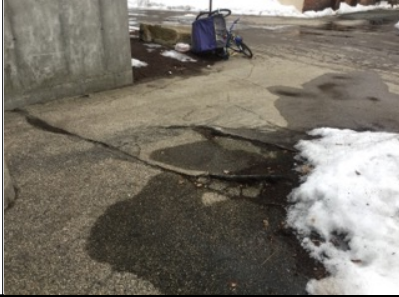
Route not maintained in operable working condition	-	Ensure the accessible route is maintained in operable working condition.	1	256	\$256
<b>Curb Ramp</b>

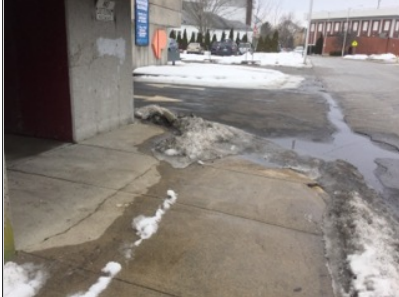
14	Route from Main Entry Ramp on Sanford Street by Academy Street	Ext.		Curb Ramp	Diagonal

Does not prevent accumulation of water	-	Repair curb ramp to prevent accumulation of water.	1	256	\$256
<b>Off-Street Parking Lot or Garage</b>												
15	Main Entrance	Ext.		Off-Street Parking Lot or Garage	Visitor

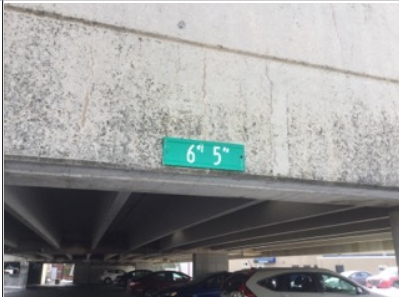
Total # of parking Total # of designated accessible parking spaces Total # of designated van accessible spaces	162 3 0	Provide one additional standard accessible space. One van accessible space is required however due to the head clearance it may be technically infeasible. IHCD recommends providing the van accessible parking space in the nearby YMCA Sanford Street Municipal Lot.	2	1850	\$3700

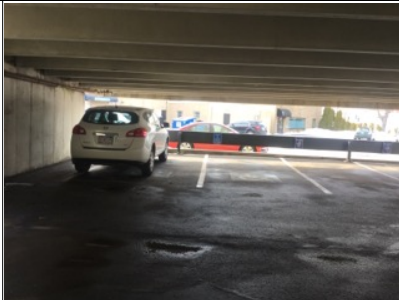
ID	Location	Floor	Room	Element	Type	Photo	Issues	Current Measure	Recommendations	Quantity	Price	Cost Estimation
16	Two Accessible Parking Spaces at the Rear of the Garage by Academy Street	1		Off-Street Parking Lot or Garage	N/A

Access aisle not provided Sign bottom < 60" above finished grade	- 15.75"	Provide a marked access aisle that is at least 60" wide. between the accessible spaces. Locate signs with the bottom of the sign 60" min. above the ground.	1	300 Labor	\$300
17	Accessible Parking Space by Condo Parking Spaces	1		Off-Street Parking Lot or Garage	N/A

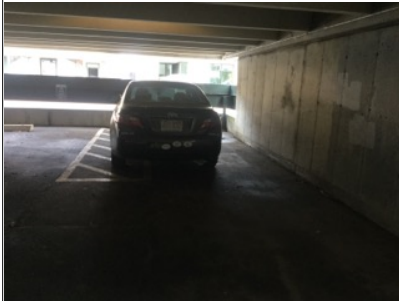
Access aisle < 60" wide at car/van space	48.5"	Provide a marked access aisle that is at least 60" wide.	1	300	\$300
18	Accessible Parking Space by Condo Parking Spaces	1		Off-Street Parking Lot or Garage	N/A

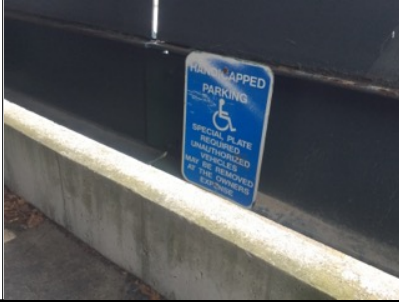
Sign bottom < 60" above finished grade	26.5"	Locate sign with the bottom of the sign 60" above the ground.	1	Labor	\$0

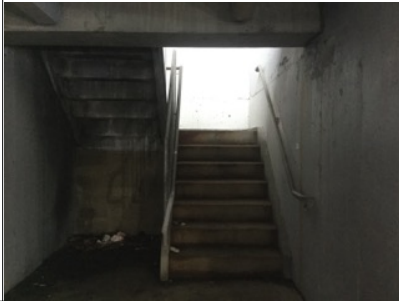
<b>Access to Goods and Services</b>												
<b>Interior Access Route</b>												
19	Base of Stair Inside the Garage	1		Interior Access Route	N/A

Vertical clearance < 80" above finished floor	-	Provide a cane-detectable barrier underneath stair.	1	960	\$960
<b>Signage</b>												
20	Near Main Entrance on the Right	1		Signage	Informational

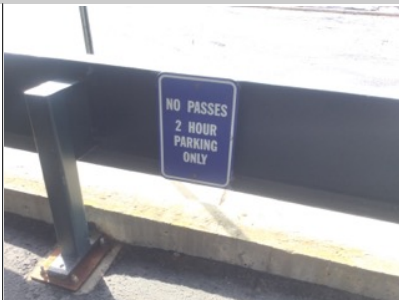
Visual characters < 40" above ground	15.75"	Mount visual sign so that the baseline of the lowest character is 40" min. above the finished floor.	1	Labor	\$0

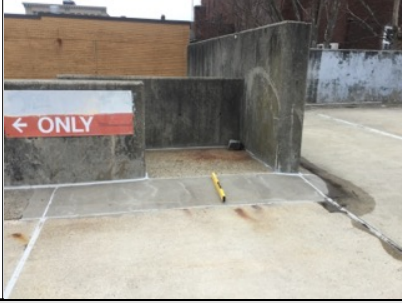
ID	Location	Floor	Room	Element	Type	Photo	Issues	Current Measure	Recommendations	Quantity	Price	Cost Estimation
21	Route to Exterior Stair From Upper Level Parking	2		Signage	Directional

Visual characters < 40" above ground	-	Mount visual sign so that the baseline of the lowest character is 40" min. above the finished floor.	1	Labor	\$0
<b>Best Practice</b>												
22	Main Entrance	Ext.

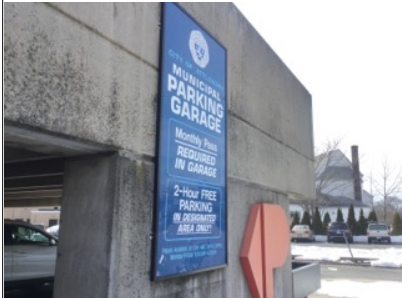
Recommend providing additional information about accessible parking spaces and how to obtain a monthly parking pass at the entry to the garage.	1	-	\$0
