Library Municipal Parking Lot

City of Attleboro ADA Transition Plan

March 2021

**City of Attleboro
Library Municipal Parking Lot**

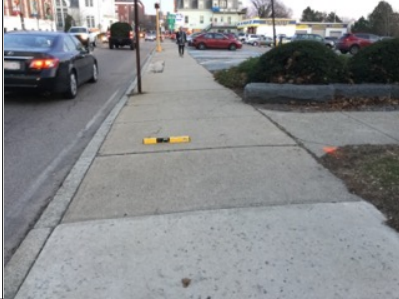
ID	Location	Floor	Room	Element	Type	Photo	Issues	Current Measure	Recommendations	Quantity	Price	Cost Estimation
Approach and Entrance												
Exterior Access Route												
1	Entry Towards Library From Sidewalk	Ext.		Exterior Access Route	Sidewalk

Cross slope > 1:50 (2.00%)	5.8%	Reduce cross slope to be no steeper than 1:50 (2.00%). (Cost estimate for rebuilding 20' concrete sidewalk.)	1	2000	\$2000
2	From Parking to Accessible Library Main Entrance	Ext.		Exterior Access Route	Walkway

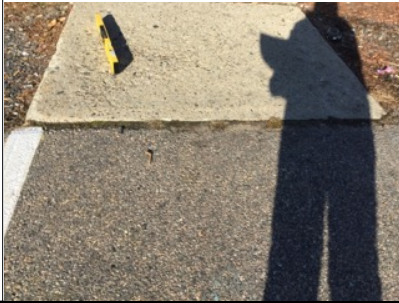
Level changes > 1/4"	.5"	Alter change in level to be 1/4" high max.	1	160	\$160
3	From Parking to Accessible Main Entrance	Ext.		Exterior Access Route	Walkway

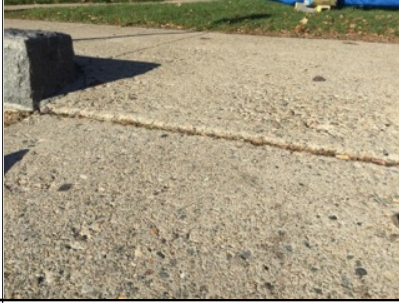
Level changes > 1/4"	1.25"	Alter change in level to be 1/4" high max.	1	256	\$256
4	Sidewalk Near Municipal Accessible Spots	Ext.		Exterior Access Route	Sidewalk

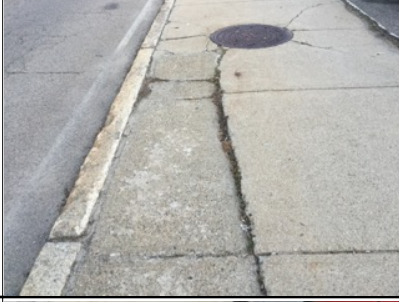
Level changes > 1/4"	1"	Alter change in level to be 1/4" high max.	1	480	\$480

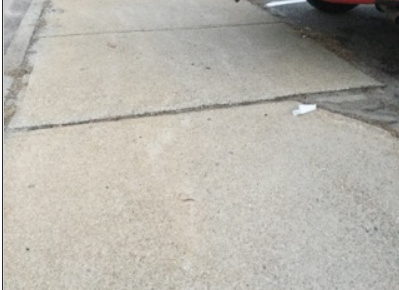
5	Sidewalk After Car Entry From Middle of Lot	Ext.		Exterior Access Route	Sidewalk

Route not maintained in operable working condition	-	Ensure the accessible route is maintained in operable working condition.	1	256	\$256

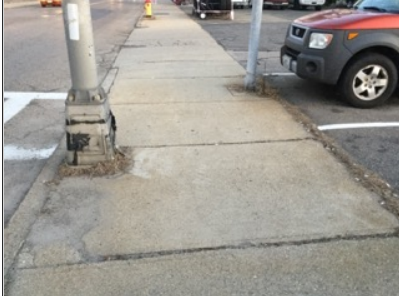
ID	Location	Floor	Room	Element	Type	Photo	Issues	Current Measure	Recommendations	Quantity	Price	Cost Estimation
6	Sidewalk After Car Entry From Middle of Lot	Ext.		Exterior Access Route	Sidewalk

Route not maintained in operable working condition	-	Ensure the accessible route is maintained in operable working condition.	1	256	\$256
7	Sidewalk In Front of Municipal Accessible Spots	Ext.		Exterior Access Route	Sidewalk

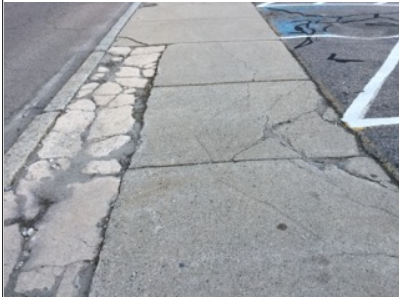
Route not maintained in operable working condition	-	Ensure the accessible route is maintained in operable working condition.	1	256	\$256
8	Sidewalk Near Municipal Accessible Spots	Ext.		Exterior Access Route	Sidewalk

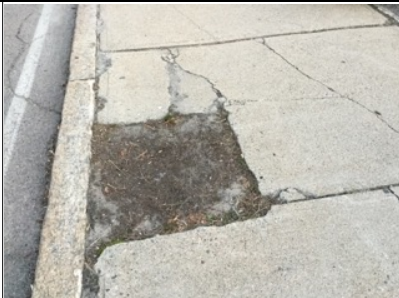
Route not maintained in operable working condition	-	Ensure the accessible route is maintained in operable working condition.	1	400	\$400
Off-Street Parking Lot or Garage												
9	3-Hour Parking for Library	Ext.		Off-Street Parking Lot or Garage	N/A

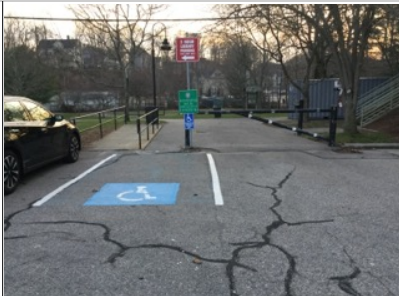
Access aisle not provided Sign bottom < 60" above finished grade	- 21.5"	Provide a marked access aisle that is at least 60" wide. Locate sign with the bottom of the sign 60" above the ground.	1	300 Labor	\$300

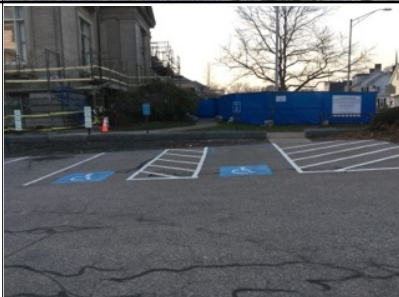
10	Accessible Parking Near 30-Minute Library and Library Staff Parking	Ext.		Off-Street Parking Lot or Garage	N/A

Sign does not have the designation "Van Accessible" Sign bottom < 60" above finished grade	- 54", 57"	Add the designation "Van Accessible" to the sign located at the van accessible space on the right. Locate signs with the bottom of the sign 60" above the ground.	1	500 Labor	\$500
Best Practice

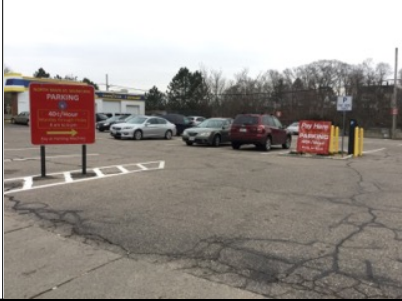
ID	Location	Floor	Room	Element	Type	Photo	Issues	Current Measure	Recommendations	Quantity	Price	Cost Estimation
11	Accessible Parking	Ext.

-	Recommend providing signage indicating that visitors with a valid accessible parking placard or license plate may park without charge up to the maximum amount of time allowed for parking in this parking lot.	1	-	\$0
12	Municipal Accessible Parking	Ext.

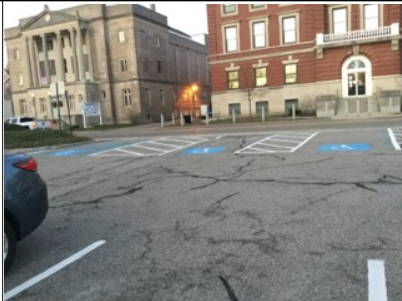
-	At the four accessible parking spaces that are in excess of the required number of accessible spaces for a parking lot of this size, IHCD recommends providing signage with the International Symbol of Accessibility (ISA).	4	-	\$0
13	Sidewalk In Front of Municipal Accessible Spots	Ext.

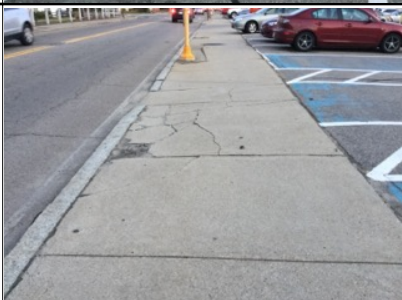
-	Recommend renovating entire sidewalk.	1	-	\$0
