# Council on Aging

## City of Attleboro ADA Transition Plan

June 2021

Institute for Human Centered Design

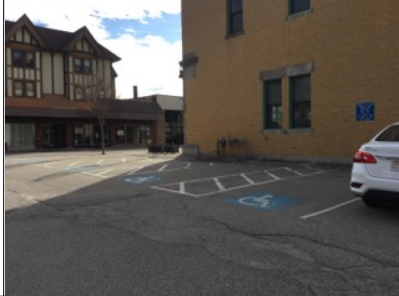
Sign not provided Sign does not have the designation "Van Accessible"	- -	Provide a sign with the bottom of the sign 60" min. above the ground and the top 96" max. above the ground at the accessible parking space closest to the entrance. Add the designation "Van Accessible" to the sign.	1	1000	\$1000
<b>Emergency Exit</b>												
2	Main Entrance	1		Emergency Exit	N/A

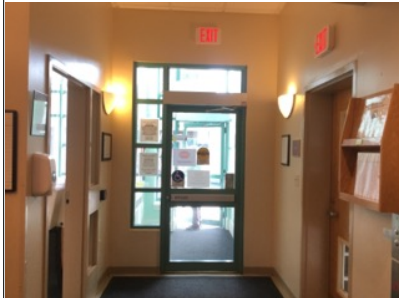
Tactile sign not provided at exit	-	Provide tactile exit signs with raised characters and braille at exit doors. Mount signs between 48"- 60" above the finished floor located on the latch side of the door.	1	232	\$232
3	Main Entrance	1		Emergency Exit	N/A

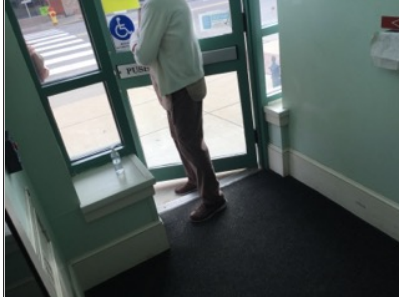
Tactile sign not provided at exit	-	Provide tactile exit signs with raised characters and braille at exit doors. Mount signs between 48"- 60" above the finished floor located on the latch side of the door.	1	232	\$232

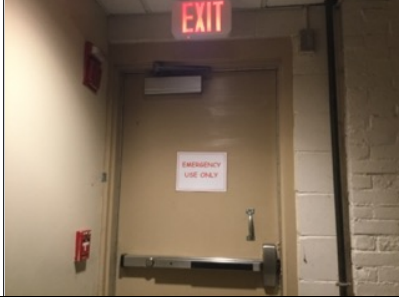
4	Stair 2 Exit	1		Emergency Exit	N/A

Tactile sign not provided at exit Directional sign to accessible emergency exit not provided	- -	Provide tactile exit signs with raised characters and braille at exit doors. Mount signs between 48"- 60" above the finished floor located on the latch side of the door. Provide a directional sign indicating the location of the nearest accessible emergency exit.	1	464	\$464
5	Exit 1 - Stair Near Main Entrance	1		Emergency Exit	N/A

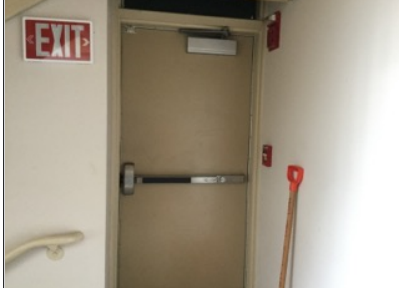
Tactile sign not provided at exit Directional sign to accessible emergency exit not provided	- -	Provide tactile exit signs with raised characters and braille at exit doors. Mount signs between 48"- 60" above the finished floor located on the latch side of the door. Provide a directional sign indicating the location of the nearest accessible emergency exit.	1	464	\$464

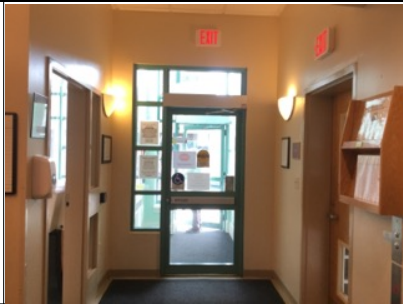
ID	Location	Floor	Room	Element	Type	Photo	Issues	Current Measure	Recommendations	Quantity	Price	Cost Estimation
6	Main Entrance	1		Emergency Exit	N/A

Illuminated Int. Symbol of Acc. not provided (MAAB)	-	When or if illuminated exit sign is replaced, provide a new illuminated sign with the International Symbol of Accessibility.	1	-	\$0
<b>Access to Goods and Services</b>												
<b>Interior Access Route</b>												
7	To Stair Near Main Entrance	1		Interior Access Route	N/A

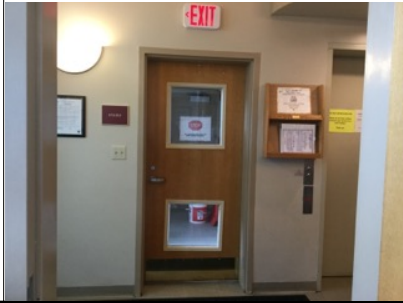
Obstructed by protruding objects	4.5"	Relocate box.	1	256	\$256
8	Reception	1		Interior Access Route	N/A

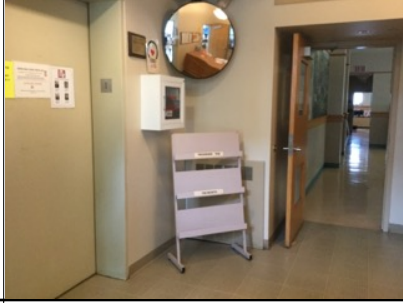
Obstructed by protruding objects	7"	Relocate defibrillator out of the circulation path.	1	256	\$256
9	To Dining From Reception - Pamphlet Panel	1		Interior Access Route	N/A

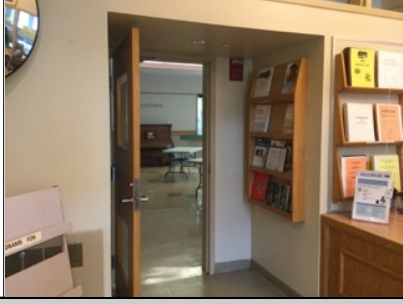
Obstructed by protruding objects	4.5"	Relocate the shelving unit out of the circulation path.	1	256	\$256
<b>Doors, Doorways, &amp; Gates</b>

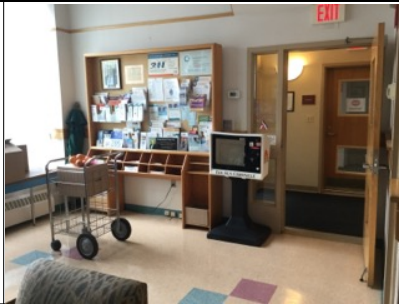
ID	Location	Floor	Room	Element	Type	Photo	Issues	Current Measure	Recommendations	Quantity	Price	Cost Estimation
11	TV/Dining Room	1		Doors, Doorways, & Gates	Other

Maneuvering clearance(s) not provided	-	Relocate newspaper dispenser out of the 18" that is required along the latch pull side of the door.	1	Labor	\$0
12	Men's Toilet Room	2		Doors, Doorways, & Gates	Toilet Room

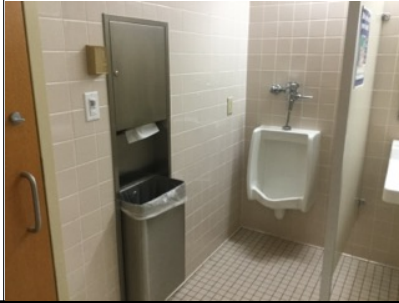
Maneuvering clearance(s) not provided	14"	Relocate trash bin to provide 18" maneuvering clearance on the latch side of the door.	1	353	\$353
13	Men's Single-User Toilet Room and Women's Multi-User Toilet Rooms	1		Doors, Doorways, & Gates

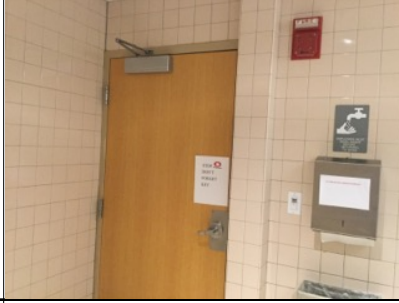
Door requires > 5 lbs. of force to open	10 lbs.	Adjust closers so doors do not require more than 5 pounds of force to open.	2	Labor	\$0
14	Stair 2	2		Doors, Doorways, & Gates	Emergency Egress

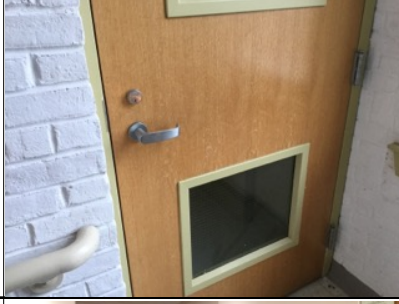
Door requires > 5 lbs. of force to open	14 lbs.	Adjust closers so doors do not require more than 5 pounds of force to open.	1	Labor	\$0

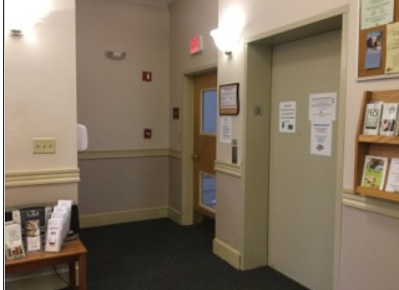
15	Stair Near Main Entrance	2		Doors, Doorways, & Gates	Emergency Egress

Door requires > 5 lbs. of force to open	10 lbs.	Adjust closers so doors do not require more than 5 pounds of force to open.	1	Labor	\$0

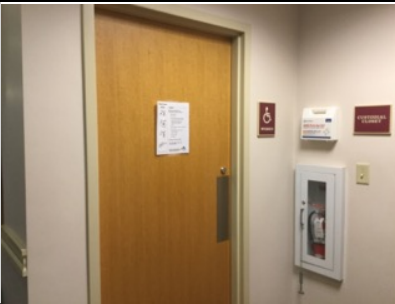
ID	Location	Floor	Room	Element	Type	Photo	Issues	Current Measure	Recommendations	Quantity	Price	Cost Estimation
16	Women's Toilet Room	2		Doors, Doorways, & Gates	Toilet Room

Door requires > 5 lbs. of force to open	14 lbs.	Adjust closers so doors do not require more than 5 pounds of force to open.	1	Labor	\$0
17	To Stair Near Main Entrance	1		Doors, Doorways, & Gates	Emergency Egress

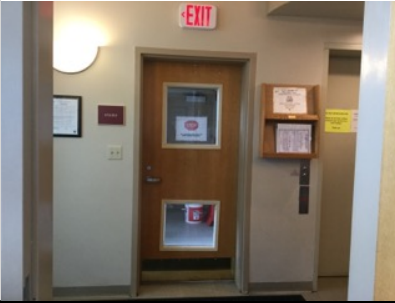
Door requires > 5 lbs. of force to open	10 lbs.	Adjust closers so doors do not require more than 5 pounds of force to open.	1	Labor	\$0
18	Fountain Near Stair 2	1		Doors, Doorways, & Gates	Circulation

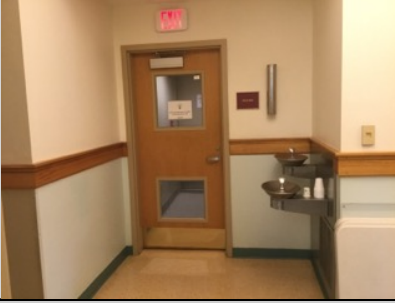
Door requires > 5 lbs. of force to open	10 lbs.	Adjust closers so doors do not require more than 5 pounds of force to open.	1	Labor	\$0
<b>Elevator</b>												
19	Elevator	1		Elevator	Interior

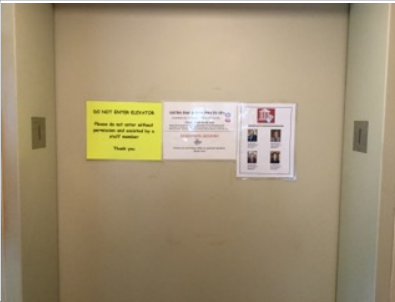
Tactile stars not provided at main entry level	-	Provide a tactile star on both sides of jambs at main floor.	2	96	\$192

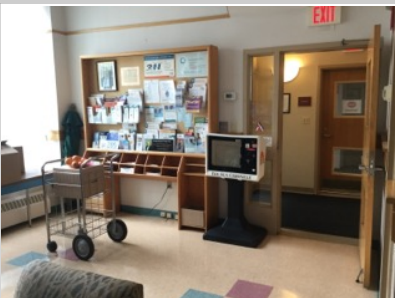
<b>Signage</b>												
20	TV/Dining Room	1		Signage	Egress

Raised characters not provided on sign Braille not provided on sign	- -	Provide text with raised characters duplicated in braille on sign.	1	232	\$232

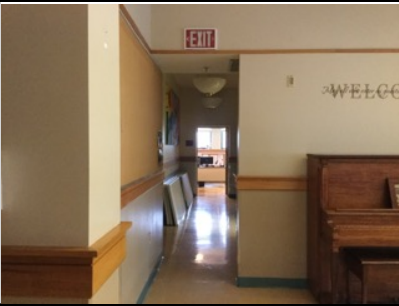
ID	Location	Floor	Room	Element	Type	Photo	Issues	Current Measure	Recommendations	Quantity	Price	Cost Estimation
21	To Activities Office	1		Signage	Egress

Raised characters not provided on sign Braille not provided on sign	- -	Provide text with raised characters duplicated in braille on sign.	1	232	\$232
22	Fountain Near Stair 2	1		Signage	Egress

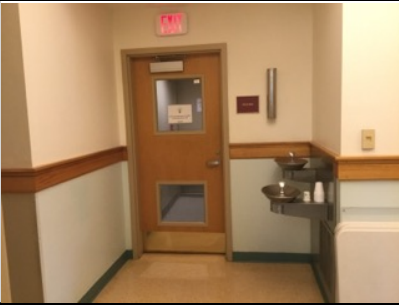
Raised characters not provided on sign Braille not provided on sign	- -	Provide text with raised characters duplicated in braille on sign.	1	232	\$232
23	Men's Single-User Toilet Room	1		Signage	Designation

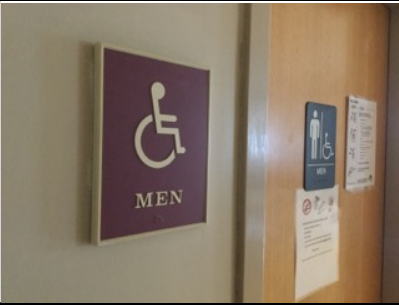
Raised characters < 48" or > 60" above ground	66"	Mount signs so that the baseline of the lowest tactile character is 48" min. above finished floor and the baseline of the highest tactile character is 60" max. above the finished floor.	1	Labor	\$0
24	Women's Multi-User Toilet Room	1		Signage	Designation

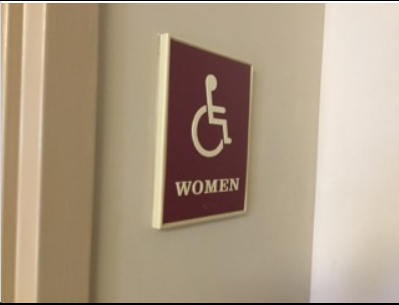
Raised characters < 48" or > 60" above ground	66"	Mount signs so that the baseline of the lowest tactile character is 48" min. above finish floor and the baseline of the highest tactile character is 60" max. above the finished floor.	1	Labor	\$0

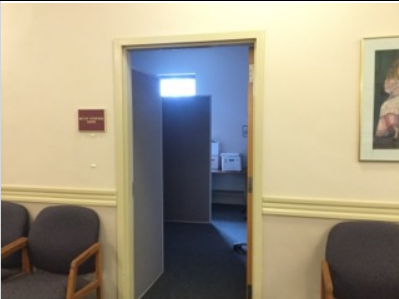
25	Common Room to Multi-Purpose Room Used for Tax/Storage	2		Signage	Designation

Sign lacks clear floor space	-	Provide a clear floor space of 18 inches minimum by 18 inches minimum, centered on the tactile characters, beyond the arc of any door swing between the closed position and 45 degree open position. Relocate chairs.	1	Labor	\$0

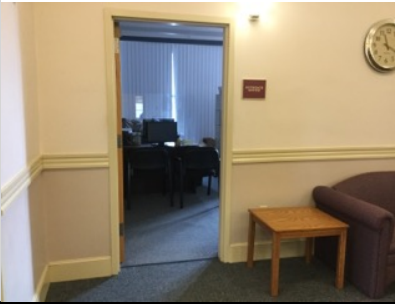
ID	Location	Floor	Room	Element	Type	Photo	Issues	Current Measure	Recommendations	Quantity	Price	Cost Estimation
26	Outreach Office	2		Signage	Designation

Sign lacks clear floor space	-	Provide a clear floor space of 18 inches minimum by 18 inches minimum, centered on the tactile characters, beyond the arc of any door swing between the closed position and 45 degree open position. Relocate table.	1	Labor	\$0
27	To SHINE Office	2		Signage	Designation

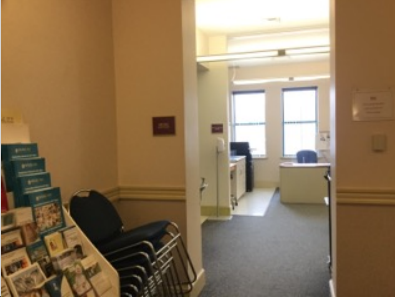
Sign lacks clear floor space	-	Provide a clear floor space of 18 inches minimum by 18 inches minimum, centered on the tactile characters, beyond the arc of any door swing between the closed position and 45 degree open position. Relocate chairs.	1	Labor	\$0
<b>Operable Parts</b>												
28	TV/Dining Room	1		Operable Parts	Clothes Rod/Hooks

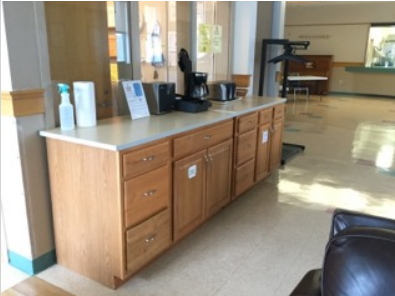
Reach < 15" or > 48"(forward/side approach)	59"	Provide a clothing rack that is no higher than 48" above the finished floor.	1	200	\$200

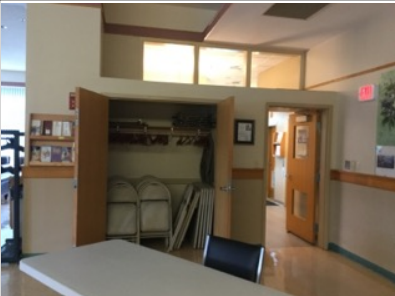
29	TV/Dining Room	1		Operable Parts	Clothes Rod/Hooks

Reach < 15" or > 48"(forward/side approach)	65.75"	Relocate clothes rod to be no higher than 48" above the finished floor.	1	256	\$256
30	Near Elevator	2		Operable Parts	Other

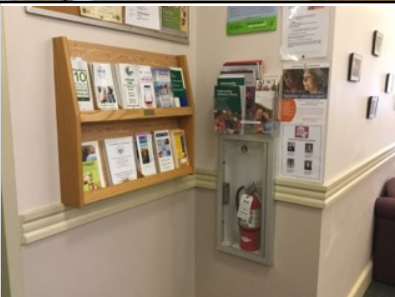
Reach < 15" or > 48"(forward/side approach)	60.5"	Ensure one of each pamphlet is located no higher than 48" above the finished floor.	1	Labor	\$0

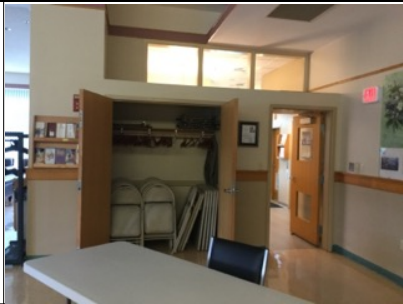
ID	Location	Floor	Room	Element	Type	Photo	Issues	Current Measure	Recommendations	Quantity	Price	Cost Estimation
31	TV/Dining Room High Pamphlet Panel	1		Operable Parts	Other

Reach < 15" or > 48"(forward/side approach)	60.75"	Ensure one of each pamphlet is located no higher than 48" above the finished floor.	1	Labor	\$0
<b>Toilet &amp; Bathing Rooms</b>												
<b>Lavatory</b>												
32	Men's Single-User Toilet Room	1		Lavatory	N/A

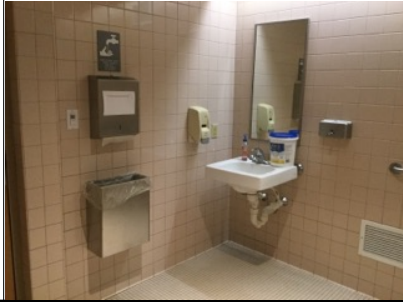
Toe or knee clearances not provided	25.75"	Provide at least one lavatory with 27" high knee and toe clearance positioned for a forward approach.	1	1686	\$1686
33	Women's Multi-User Toilet Room	1		Lavatory	N/A

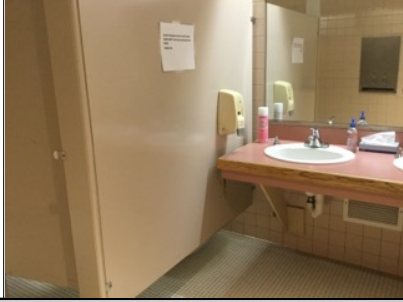
Toe or knee clearances not provided	26"	Provide at least one lavatory with 27" high knee and toe clearance positioned for a forward approach.	1	1686	\$1686
<b>Single-User Toilet</b>												
34	Men's Single-User Toilet Room	1		Single-User Toilet

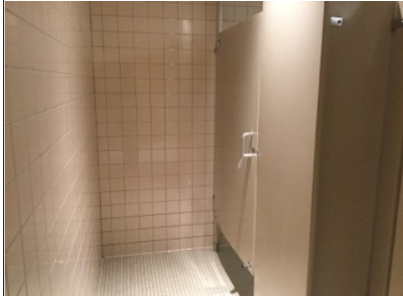
Door has inadequate maneuvering clearance	35.75"	It may be technically infeasible to correct the maneuvering clearance.	1	-	\$0

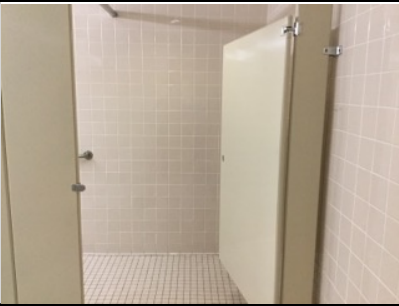
ID	Location	Floor	Room	Element	Type	Photo	Issues	Current Measure	Recommendations	Quantity	Price	Cost Estimation
36	Men's Toilet Room	2		Toilet Compartment	Accessible Compartment

Door has malfunctioning self-closing hinge	-	Repair hinge.	1	Labor	\$0
37	Women's Toilet Room	2		Toilet Compartment	Accessible Compartment

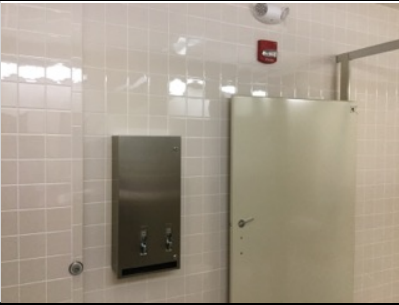
Door has malfunctioning self-closing hinge	-	Repair hinge.	1	Labor	\$0
38	Men's Toilet Room	2		Toilet Compartment	Accessible Compartment

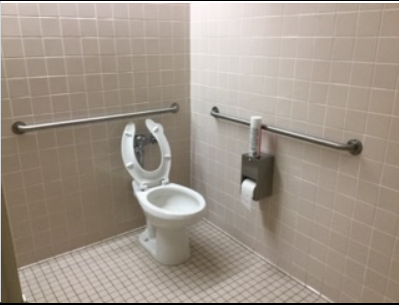
Side or rear grab bar < 33" or >36" high	37.5"	Locate grab bars between 33"- 36" above the finished floor.	2	396	\$792
39	Women's Toilet Room	2		Toilet Compartment	Accessible Compartment

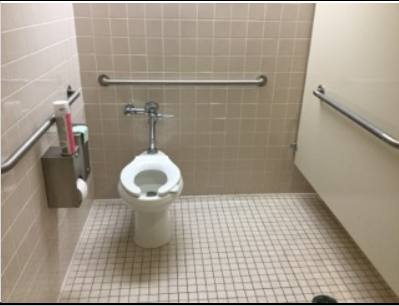
Side or rear grab bar < 33" or >36" high Coat hook > 48"	36.75" 55"	Locate grab bars between 33"- 36" above the finished floor. Lower coat hook so that it is no higher than 48".	1	942	\$942
<b>Urinal</b>												
40	Men's Toilet Room	2		Urinal	N/A

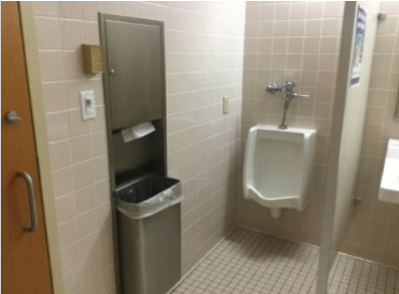
Rim > 17" high Clear floor space not provided at urinal Flush control too high or not properly located Urinal recessed > 24" has > 36" clear width	18.5" 29.25" 45.5" 33"	Provide at least one urinal with the rim no higher than 17" above the finished floor. Remove and replace partition and or trash bin to provide a 30" min. by 48" min. clear floor space positioned for a forward approach. If urinal is recessed greater than 24" ensure there is a clear width of 36" is required and a shorter partition may work better. Mount flush control at 44" max. above the finished floor.	1	4075	\$4075

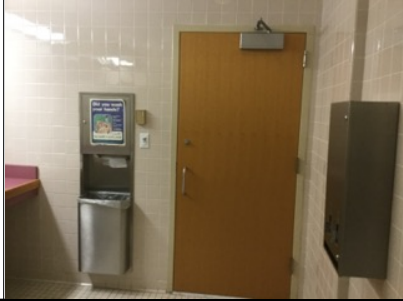
ID	Location	Floor	Room	Element	Type	Photo	Issues	Current Measure	Recommendations	Quantity	Price	Cost Estimation
<b>Dispensers</b>												
41	Women's Toilet Room	2		Dispensers	Tampon Dispenser

Dispenser acts as a protruding object	7"	Relocate tampon dispenser out of the circulation path.	1	353	\$353
<b>Additional Access</b>												
<b>Drinking Fountains</b>												
42	SHINE Office	2		Drinking Fountains	Hi-Lo

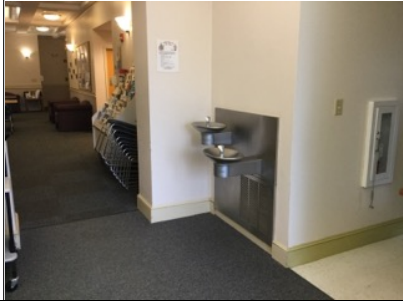
Knee or toe clearance not provided	25.75"	Provide knee and toe clearance, 27" min. high at drinking fountain for seated users.	1	2028	\$2028
<b>Best Practice</b>												
43	TV/Dining Room	1			-

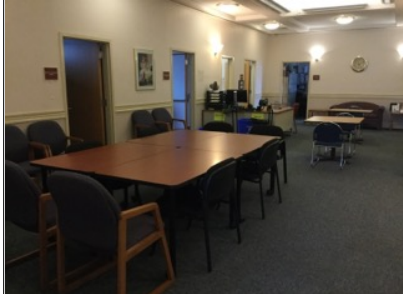
This is a good example of a space containing chairs with and without arms.	1	-	\$0
