# Parks and Forestry Building

## City of Attleboro ADA Transition Plan

April 2021

Institute for Human Centered Design

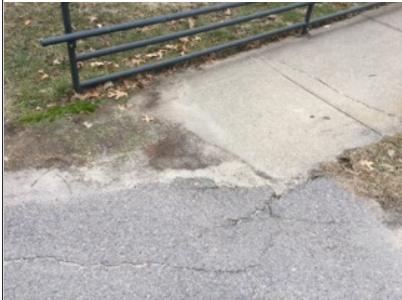
| ID | Location | Floor | Room | Element | Type | Photo | Issues | Current Measure | Recommendations | Quantity | Price | Cost Estimation |
|---|---|---|---|---|---|--|--|---|--|---|---|---|
| 1 | Accessible Route to Main Entrance | Ext. | | Exterior Access Route | Walkway | | Level changes > 1/4"<br>Surface is not stable, firm, and slip-resistant | 1.5"<br>- | Alter change in level to be 1/4" high max.<br>Repair surface. | 1 | 160 | \$160 |

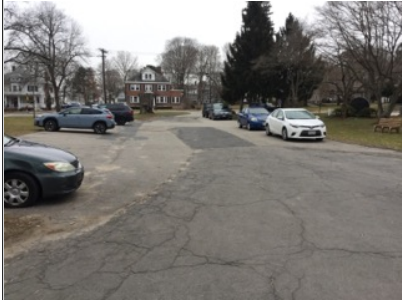
| ID | Location | Floor | Room | Element | Type | Photo | Issues | Current Measure | Recommendations | Quantity | Price | Cost Estimation |
|---|---|---|---|---|---|--|--|---|--|---|---|---|
| 2 | Parking Lot | Ext. | | Off-Street Parking Lot or Garage | Visitor | | Total # of parking<br>Total # of designated accessible parking spaces<br>Total # of designated van accessible spaces | 19<br>0<br>0 | Provide one van accessible parking space. | 1 | 1850 | \$1850 |

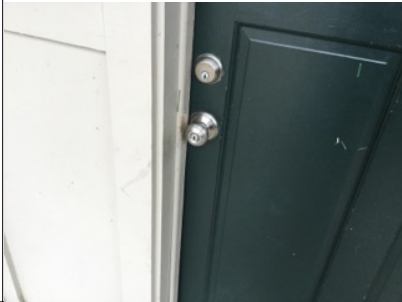
| ID | Location | Floor | Room | Element | Type | Photo | Issues | Current Measure | Recommendations | Quantity | Price | Cost Estimation |
|---|---|---|---|---|---|--|--|---|--|---|---|---|
| 3 | Main Entrance | Ext. | | Entrance | Main Entrance | | Hardware not operable with a closed fist | - | Provide hardware that can be operable with one hand and not require tight grasping, pinching, or twisting of the wrist. | 1 | 484 | \$484 |

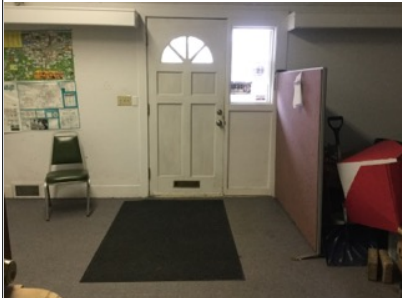
| ID | Location | Floor | Room | Element | Type | Photo | Issues | Current Measure | Recommendations | Quantity | Price | Cost Estimation |
|---|---|---|---|---|---|--|--|---|--|---|---|---|
| 4 | Main Entrance (Egress) | 1 | | Emergency Exit | | | Tactile sign not provided at exit<br>Mat not securely attached | -<br>- | Provide tactile exit signs with raised characters and braille at exit doors. Mount signs between 48"- 60" above the finished floor located on the latch side of the door.<br>Secure the mat. | 1 | 232<br>Labor | \$232 |

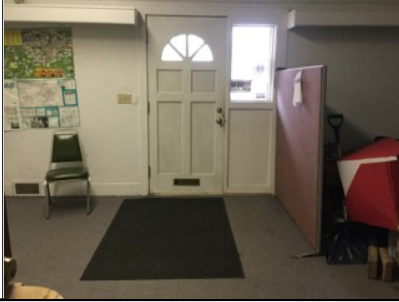
| ID | Location | Floor | Room | Element | Type | Photo | Issues | Current Measure | Recommendations | Quantity | Price | Cost Estimation |
|---|---|---|---|---|---|--|---|---|--|---|---|---|
| 5 | Main Entrance | Ext. | | Emergency Exit | N/A | | Illuminated Int. Symbol of Acc. not provided (MAAB) | | If an illuminated sign is provided at the exit provide an illuminated sign with the International Symbol of Accessibility. | 1 | - | \$0 |

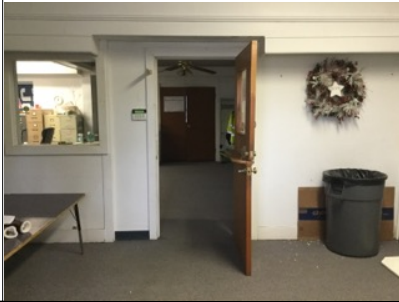
| ID | Location | Floor | Room | Element | Type | Photo | Issues | Current Measure | Recommendations | Quantity | Price | Cost Estimation |
|---|---|---|---|---|---|--|---|---|--|---|---|---|
| 6 | Administrative Office | 1 | | Doors, Doorways, & Gates | Office | | Hardware not operable with a closed fist | - | Provide hardware that can be operable with one hand and not require tight grasping, pinching, or twisting of the wrist. | 1 | 484 | \$484 |

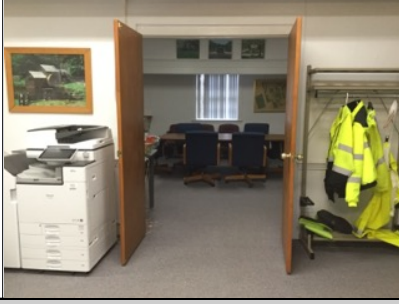
| ID | Location | Floor | Room | Element | Type | Photo | Issues | Current Measure | Recommendations | Quantity | Price | Cost Estimation |
|---|---|---|---|---|---|--|---|---|--|---|---|---|
| 7 | Commission Meeting Room | 1 | | Doors, Doorways, & Gates | | | Hardware not operable with a closed fist | - | Provide hardware that can be operable with one hand and not require tight grasping, pinching, or twisting of the wrist. | 1 | 484 | \$484 |

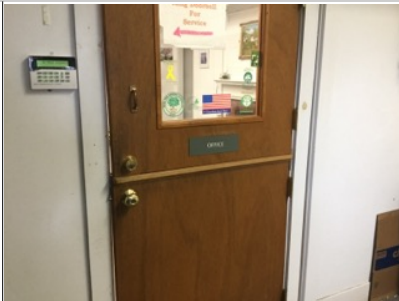
| ID | Location | Floor | Room | Element | Type | Photo | Issues | Current Measure | Recommendations | Quantity | Price | Cost Estimation |
|---|---|---|---|---|---|--|---|---|--|---|---|---|
| 8 | Administrative Office | 1 | | Signage | Designation | | Sign not located on the latch side of the door | - | Locate sign at permanent rooms alongside the door on the latch side. | 1 | Labor | \$0 |

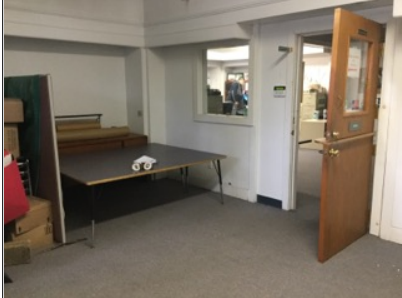
| ID | Location | Floor | Room | Element | Type | Photo | Issues | Current Measure | Recommendations | Quantity | Price | Cost Estimation |
|---|---|---|---|---|---|--|---|---|---|---|---|---|
| 9 | Main Entrance Lobby | 1 | | Dining or Work Surfaces | Work Surface | | Knee or toe clearance not provided<br>Top of dining/work surface < 28" or > 34" | 23.75"<br>24.5" | Provide at least one dining or work surface with tops between 28"- 34" above the floor and 27" clear height underneath. Adjust the table. | 1 | Labor | \$0 |

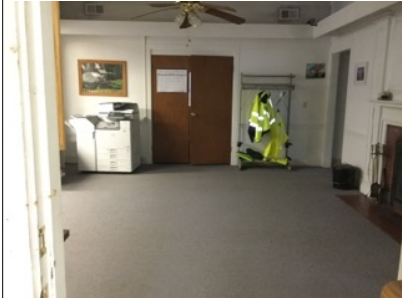
| ID | Location | Floor | Room | Element | Type | Photo | Issues | Current Measure | Recommendations | Quantity | Price | Cost Estimation |
|---|---|---|---|---|---|--|---|---|---|---|---|---|
| 10 | Commission Meeting Room | 1 | | | - | | | - | Recommend providing accessible designation signage with raised characters and braille mounted on the latch side of the door at permanent rooms that lack designation signage. | 1 | - | \$0 |

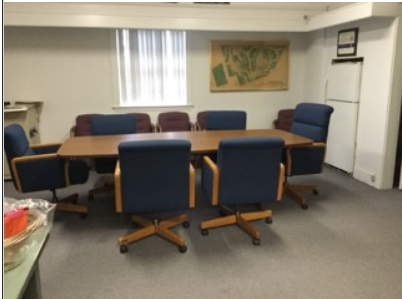
| ID | Location | Floor | Room | Element | Type | Photo | Issues | Current Measure | Recommendations | Quantity | Price | Cost Estimation |
|---|---|---|---|---|---|--|---|---|---|---|---|---|
| 11 | Commission Meeting Room | 1 | | | - | | | - | This is a good example of an accessible table with knee and toe clearance. | 1 | - | \$0 |

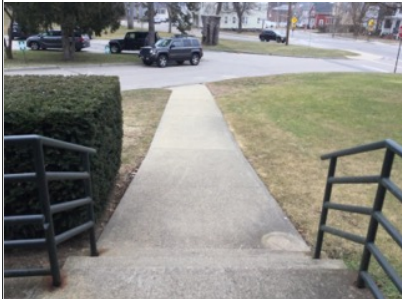
| ID | Location | Floor | Room | Element | Type | Photo | Issues | Current Measure | Recommendations | Quantity | Price | Cost Estimation |
|---|---|---|---|---|---|--|---|---|---|---|---|---|
| 12 | Main Entrance | Ext. | | | - | | | - | Recommend providing contrasting strips on stair treads at the exterior stair. | 1 | - | \$0 |
