# Police Station

## City of Attleboro ADA Transition Plan

June 2021

**City of Attleboro  
Police Station**

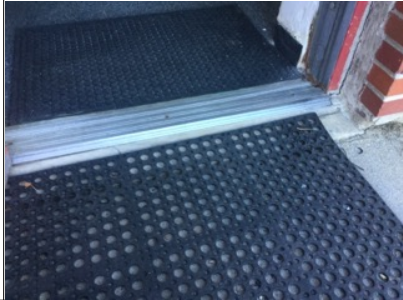
ID	Location	Floor	Room	Element	Type	Photo	Issues	Current Measure	Recommendations	Quantity	Price	Cost Estimation
<b>Approach and Entrance</b>												
<b>Exterior Access Route</b>												
1	Exit 1	Ext.		Exterior Access Route	Walkway

Surface is not stable, firm, and slip-resistant	-	Secure the mat.	1	Labor	\$0
<b>Off-Street Parking Lot or Garage</b>												
2	Accessible Parking	Ext.		Off-Street Parking Lot or Garage	Visitor

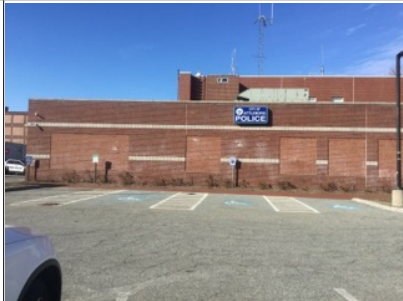
Van space < 132" or <96" wide Access aisle < 60" wide at car/van space Sign not provided Sign does not have the designation "Van Accessible"	- 49" 2 -	No van accessible space is provided and all of the access aisles are less than 60" wide. The lot requires 2 standard accessible spaces and one van accessible space. Provide a van accessible space that is at least 132" wide. Provide two marked access aisles that are at least 60" wide. Provide signage at two spaces and add the designation "Van Accessible" to the sign located at the van accessible space.	1	2100	\$2100

Accessibility issues include lack of a van accessible parking space, lack of signage at two (2) accessible parking spaces and lack of access aisles that are the minimum required width. In addition, signage at one (1) accessible parking space is mounted lower than allowed.

- Renovate accessible parking spaces: \$2,100
- Miscellaneous corrective actions (securing mats, operable parts, signage, protruding objects, relocating the fingerprinting shelf, etc.): \$578

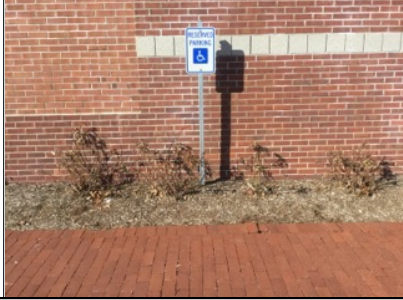
3	Accessible Parking	Ext.		Off-Street Parking Lot or Garage	Visitor

Sign bottom < 60" above finished grade	48"	Locate sign with the bottom of the sign 60" above the ground.	1	Labor	\$0
<b>Entrance</b>												
4	To Main Entrance From Staff Parking	Ext.		Entrance	Main Entrance

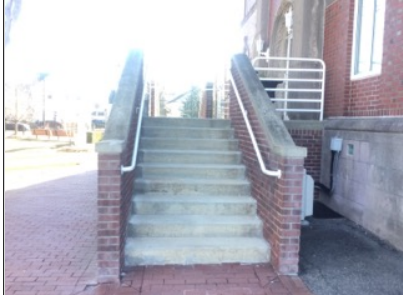
Entrance not on an accessible route Directional sign to accessible entrance not provided	- -	Provide a directional sign indicating the location of the nearest accessible entrance. Recommend providing a contact phone number on the sign and alerting the public on the police station website about procedures for gaining access via an accessible route to the police station.(Cost includes exterior sign only.)	1	346	\$346

The entrance to the main lobby is not accessible because it is up a set of stairs. A directional sign indicating the location of the nearest accessible entrance must be provided at the base of the stair. In addition, IHCD recommend providing a contact phone number on the sign and alerting the public on the police station website about procedures for gaining access via an accessible route to the police station.

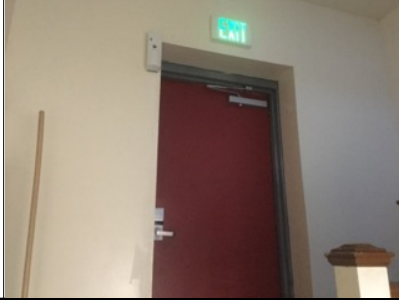
ID	Location	Floor	Room	Element	Type	Photo	Issues	Current Measure	Recommendations	Quantity	Price	Cost Estimation
<b>Emergency Exit</b>												
5	Exit 1	.5		Emergency Exit	N/A

Tactile sign not provided at exit	-	Provide tactile exit signs with raised characters and braille at exit doors. Mount signs between 48"- 60" above the finished floor located on the latch side of the door.	1	232	\$232
<b>Access to Goods and Services</b>												
<b>Interior Access Route</b>												
6	Fingerprinting Area	B		Interior Access Route	N/A

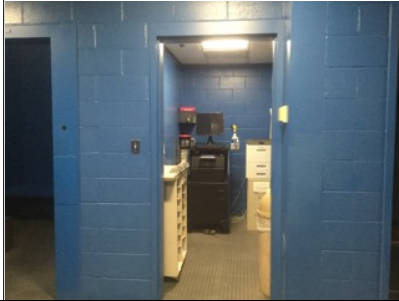
Route < 36" wide	33"	Relocate fingerprinting shelf to provide 36" clear.	1	Labor	\$0
7	Main Entrance	1		Interior Access Route	N/A

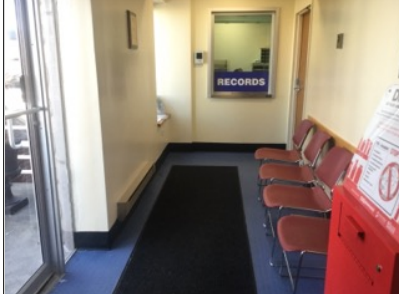
Surface not stable, firm, and slip-resistant	-	Secure the mat.	1	Labor	\$0
