Wastewater Department

City of Attleboro ADA Transition Plan

April 2021

**City of Attleboro
Wastewater Department**

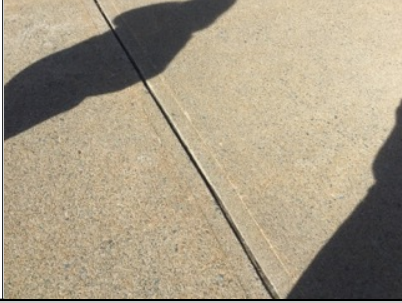
ID	Location	Floor	Room	Element	Type	Photo	Issues	Current Measure	Recommendations	Quantity	Price	Cost Estimation
Approach and Entrance												
Exterior Access Route												
1	Towards Main Entrance	Ext.		Exterior Access Route	Sidewalk

- There is a surface opening greater than allowed on the exterior route to the main entrance.
- Lack of signage with raised characters and braille at the exit door.
- The mat by the entrance is not secured.
- Informational signage by the reception area lacks a non-glare finish.

Surface openings > 1/2"	-	Repair the gap so that the opening is 1/2" max.	1	256	\$256
Curb Ramp												
2	Main Entrance	Ext.		Curb Ramp	N/A

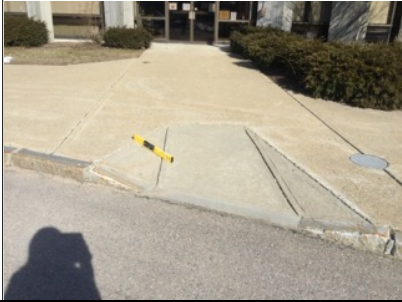
Accessibility issues at the curb ramp to the main entrance include one flare that has a steeper slope than allowed.

Curb ramp flares > 1:10 (10%)	11.4%	Reduce slope at curb ramp flares to be no steeper than 1:10 (10%). (Cost estimate for a new concrete curb ramp.)	1	2800	\$2800
Off-Street Parking Lot or Garage												
3	Accessible Parking	Ext.		Off-Street Parking Lot or Garage	Visitor

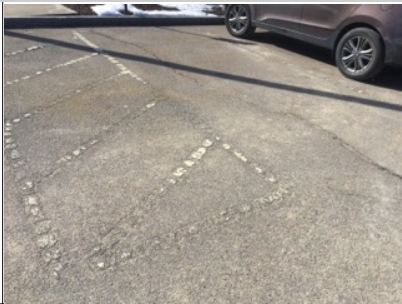
Accessibility issues include lack of a van accessible parking space. Currently the accessible parking space is only wide enough to be considered a car accessible parking space, the access aisle is faded and the accessible parking sign is located lower than allowed. When it is converted into a compliant van accessible parking space, an identification sign with the designation “Van Accessible” should be added.

Total # of designated van accessible spaces Access aisle not compliant Sign does not have the designation "Van Accessible" Sign bottom < 60" above finished grade	0 59" - 41.75"	Provide one van accessible space with a compliant access aisle. Current access aisle is too narrow for a van accessible space and faded. Add the designation "Van Accessible" to the sign located at the van accessible space. Locate existing accessible parking sign with the bottom of the sign 60" above the ground.	1	800 Labor	\$800

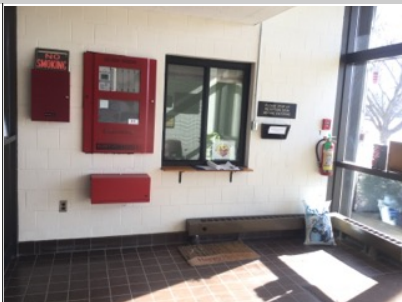
Entrance												
4	Reception	1		Entrance	Main Entrance

Mat not securely attached	-	Secure the mat.	1	Labor	\$0

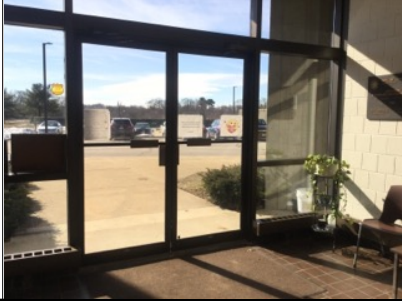
ID	Location	Floor	Room	Element	Type	Photo	Issues	Current Measure	Recommendations	Quantity	Price	Cost Estimation
Emergency Exit												
5	Main Entrance	1		Emergency Exit

Tactile sign not provided at exit		Provide tactile exit signs with raised characters and braille at exit doors. Mount signs between 48"- 60" above the finished floor located on the latch side of the door.	1	232	\$232
6	Main Entrance	1		Emergency Exit	N/A

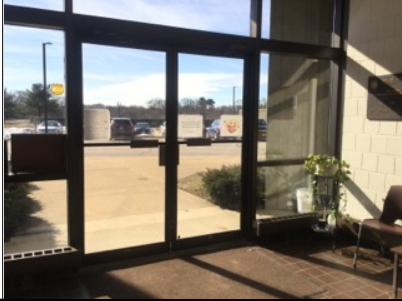
Illuminated Int. Symbol of Acc. not provided (MAAB)	-	If an illuminated exit sign is provided, provide an illuminated sign with the International Symbol of Accessibility.	1	-	\$0
Access to Goods and Services												
Signage												
7	Reception Area	1		Signage	Informational

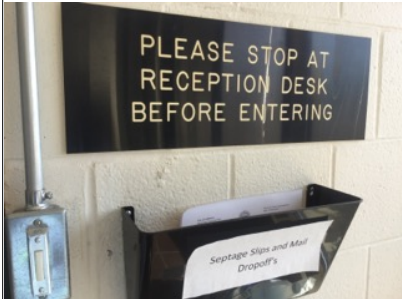
Non glare finish and contrast not provided on sign	-	Install a sign with a non-glare finish with characters that have a high contrast to the background.	1	232	\$232
