Department of Public Works

City of Attleboro ADA Transition Plan

April 2021

**City of Attleboro
Department of Public Works**

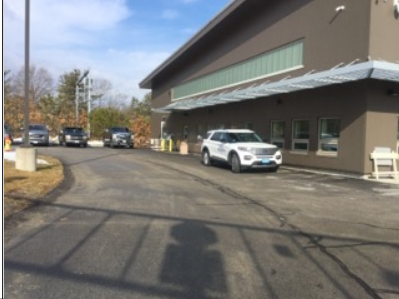
ID	Location	Floor	Room	Element	Type	Photo	Issues	Current Measure	Recommendations	Quantity	Price	Cost Estimation
Approach and Entrance												
Off-Street Parking Lot or Garage												
1	Side Entry Parking	Ext.		Off-Street Parking Lot or Garage	N/A

Total # of designated accessible parking spaces Total # of designated van accessible spaces Access aisle not provided Sign not provided Sign does not have the designation "Van Accessible"	- - - -	Provide a compliant van accessible parking 96" wide min. with a marked access aisle that is at least 96" wide. Provide a sign with the International Symbol of Accessibility (ISA) with the bottom of the sign 60" min. above the ground and the top 96" max. above the ground. Add the designation "Van Accessible" to the sign located at the van accessible space.	1	1850	\$1850
Emergency Exit												
2	Main Entrance	1		Emergency Exit	N/A

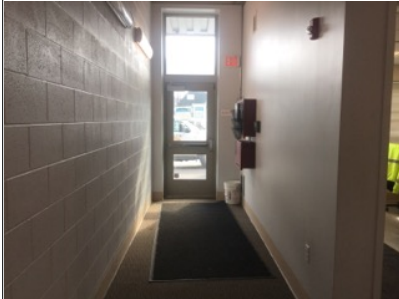
Illuminated Int. Symbol of Acc. not provided (MAAB)	-	If the exit sign is replaced with a new illuminated exit sign, provide an illuminated International Symbol of Accessibility (ISA).	1	-	\$0

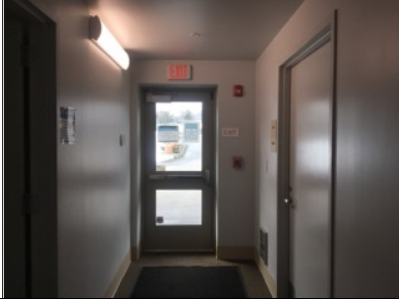
3	Secondary Entrance	1		Emergency Exit	N/A

Illuminated Int. Symbol of Acc. not provided (MAAB)		If the exit sign is replaced with a new illuminated exit sign, provide an illuminated International Symbol of Accessibility (ISA).	1	-	\$0
Access to Goods and Services												
Interior Access Route												
4	Main Entrance	1		Interior Access Route	N/A

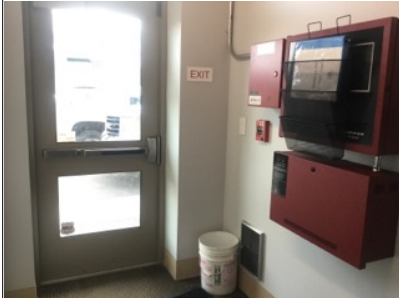
Obstructed by protruding objects	29.75"	Provide a cane-detectable barrier that is 27" max. above the finished floor below equipment that protrudes into the circulation path.	1	306	\$306

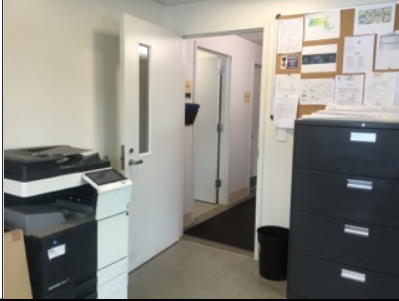
ID	Location	Floor	Room	Element	Type	Photo	Issues	Current Measure	Recommendations	Quantity	Price	Cost Estimation
Doors, Doorways, & Gates												
5	Superintendent	1		Doors, Doorways, & Gates	Office

Maneuvering clearance(s) not provided	-	Relocate trash can to provide 18" min. pull-side maneuvering clearance at the door.	1	Labor	\$0
6	Main Entrance	1		Doors, Doorways, & Gates	Emergency Egress

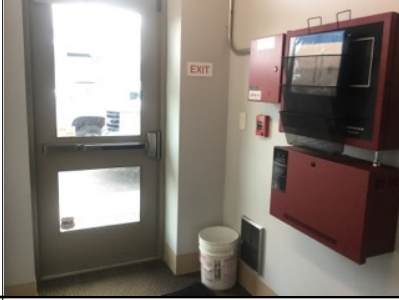
Maneuvering clearance(s) not provided Clear floor space not provided at emergency egress sign	-	Remove trash can.	1	Labor	\$0
7	Women's Toilet Room	1		Doors, Doorways, & Gates	Toilet Room

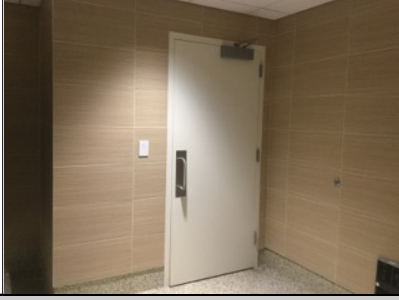
Door requires > 5 lbs. of force to open	10 lbs.	Adjust closers so doors do not require more than 5 pounds of force to open.	1	Labor	\$0
Signage												
8	All Offices	1		Signage	Designation
