Water Department

City of Attleboro ADA Transition Plan

June 2021

West Street Water Treatment Facility
Year Built: 1995

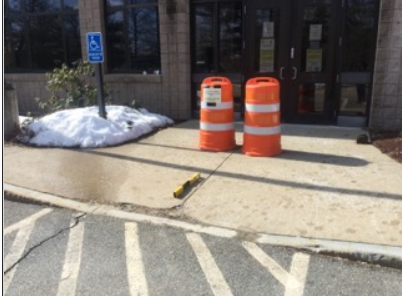
ID	Location	Floor	Room	Element	Type	Photo	Issues	Current Measure	Recommendations	Quantity	Price	Cost Estimation
Approach and Entrance												
Curb Ramp												
1	Main Entrance	Ext.		Curb Ramp	N/A

Surface not stable, firm and slip-resistant	-	Repair surface.	1	144	\$144
Off-Street Parking Lot or Garage												
2	Main Entrance	Ext.		Off-Street Parking Lot or Garage	Visitor

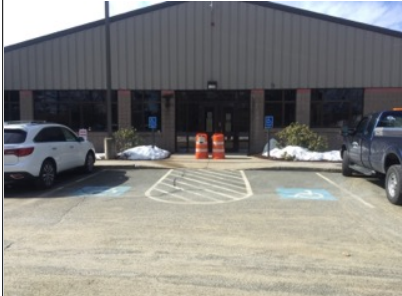
Total # of designated van accessible spaces	-	Enlarge one accessible parking space to be a van accessible parking space. Add the designation "Van Accessible" to the sign located at the van accessible space.	1	800	\$800
Emergency Exit												
3	Main Entrance (Egress)	1		Emergency Exit	N/A

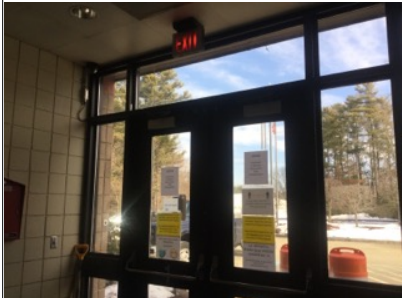
Tactile sign not provided at exit	- -	Provide tactile exit signs with raised characters and braille at exit doors. Mount signs between 48"- 60" above the finished floor located on the latch side of the door. Where a tactile sign is provided at double doors with two active leafs, the sign shall be located to the right of the right hand door.	1	232	\$232

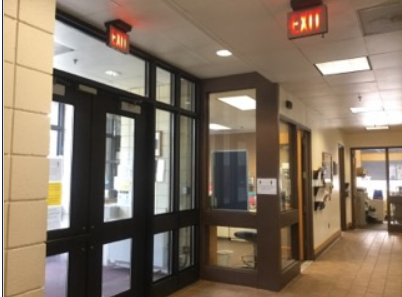
4	Main Entrance (Egress)	1		Emergency Exit	N/A

Tactile sign not provided at exit	-	Provide tactile exit signs with raised characters and braille at exit doors. Mount signs between 48"- 60" above the finished floor located on the latch side of the door. Where a tactile sign is provided at double doors with two active leafs, the sign shall be located to the right of the right hand door.	1	232	\$232

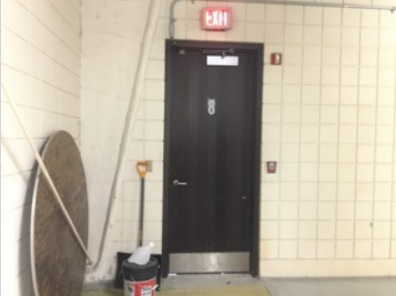
ID	Location	Floor	Room	Element	Type	Photo	Issues	Current Measure	Recommendations	Quantity	Price	Cost Estimation
5	Exit 2	1		Emergency Exit	N/A

Tactile sign not provided at exit		Provide tactile exit signs with raised characters and braille at exit doors. Mount signs between 48"- 60" above the finished floor located on the latch side of the door.	1	232	\$232
6	Exit 2	1		Emergency Exit	N/A

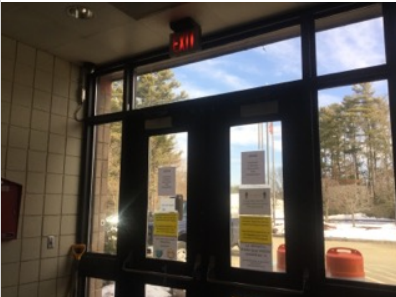
Illuminated Int. Symbol of Acc. not provided (MAAB)	-	When illuminated signage is replaced at this exit, provide new illuminated signage with the International Symbol of Accessibility.	1	-	\$0
7	Exit 2	1		Emergency Exit	N/A

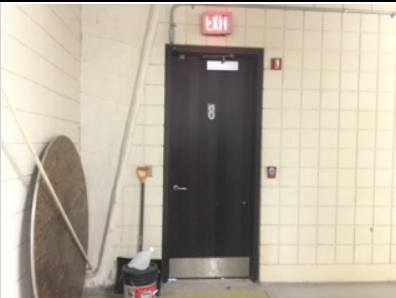
Illuminated Int. Symbol of Acc. not provided (MAAB)	-	When illuminated signage is replaced at this exit, provide new illuminated signage with the International Symbol of Accessibility.	1	-	\$0
8	Exit 2	Ext.		Emergency Exit	N/A

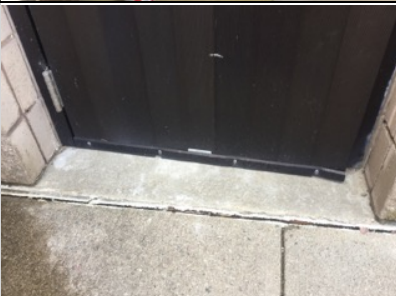
Threshold > 1/2" high	1"	Alter the threshold to be 1/2" high max.	1	150	\$150

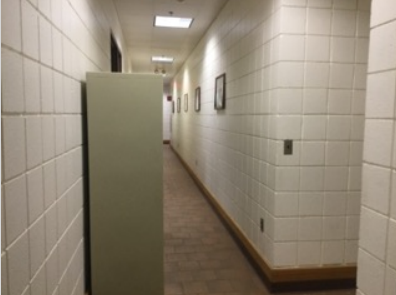
Access to Goods and Services												
Interior Access Route												
9	Corridor to Main Entrance	1		Interior Access Route	N/A

Route < 36" wide	35.5"	Ensure that a clear width of 36" min. is maintained at the accessible route. Relocate shelf.	1	Labor	\$0

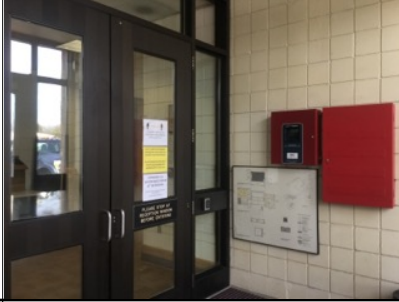
ID	Location	Floor	Room	Element	Type	Photo	Issues	Current Measure	Recommendations	Quantity	Price	Cost Estimation
Doors, Doorways, & Gates												
10	Main Entrance	1		Doors, Doorways, & Gates	Vestibule

Door requires > 5 lbs. of force to open	10 lbs.	Adjust closers so doors do not require more than 5 pounds of force to open.	1	Labor	\$0
11	Women's Toilet Room	1		Doors, Doorways, & Gates	Toilet Room

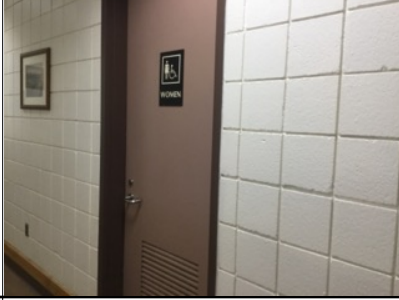
Door requires > 5 lbs. of force to open	11 lbs.	Adjust closers so doors do not require more than 5 pounds of force to open.	1	Labor	\$0
12	Route to Secondary Exit	1		Doors, Doorways, & Gates	Assembly Space

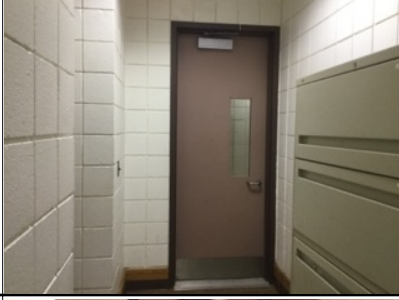
Door requires > 5 lbs. of force to open	10 lbs.	Adjust closers so doors do not require more than 5 pounds of force to open.	1	Labor	\$0
13	Men's Toilet Room	1	E	Doors, Doorways, & Gates	Toilet Room

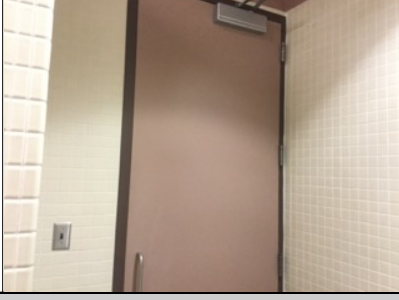
Door requires > 5 lbs. of force to open	15 lbs.	Adjust closers so doors do not require more than 5 pounds of force to open.	1	Labor	\$0

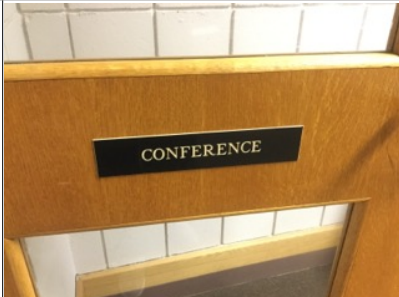
Signage												
14	Conference Room	1		Signage	Designation

<p>Raised characters not provided on sign</p> <p>Raised characters < 48" or > 60" above ground</p> <p>Braille not provided on sign</p> <p>Sign not located on the latch side of the door</p>	- 36.5" - -	<p>Provide text with raised characters duplicated in braille on sign. Mount signs so that the baseline of the lowest tactile character is 48" min. above finished floor and the baseline of the highest tactile character is 60" max. above the finished floor.</p> <p>Locate sign at permanent rooms alongside the door on the latch side.</p>	1	232	\$232

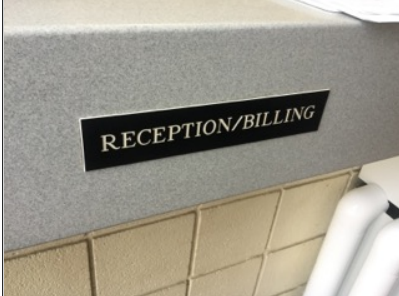
ID	Location	Floor	Room	Element	Type	Photo	Issues	Current Measure	Recommendations	Quantity	Price	Cost Estimation
15	Main Entrance - Reception	1		Signage	Designation

Visual characters < 40" above ground	34.5"	Mount visual sign so that the baseline of the lowest character is 40" min. above the finished floor.	1	Labor	\$0
16	Main Entrance	1		Signage	Informational

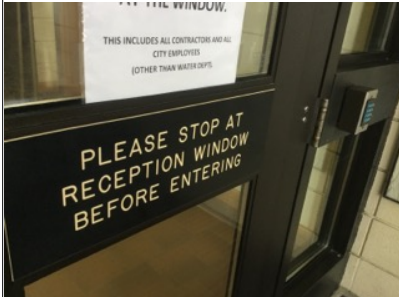
Visual characters < 40" above ground	34.5"	Mount visual sign so that the baseline of the lowest character is 40" min. above the finished floor.	1	Labor	\$0
17	Men's and Women's Toilet Rooms	1		Signage	Designation

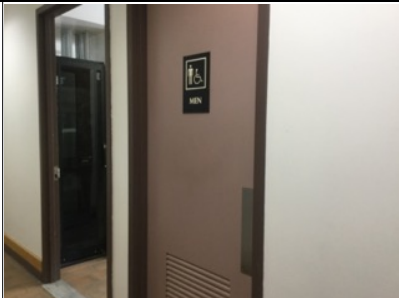
Sign not located on the latch side of the door	-	Locate sign at permanent rooms alongside the door on the latch side.	2	Labor	\$0
Service Counter												
18	Main Entrance - Reception	1		Service Counter	N/A

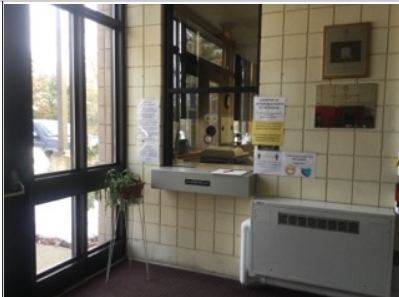
Counter > 36" high	41.75"	Provide a counter that is 36" max. above the ground or finished floor.	1	880	\$880

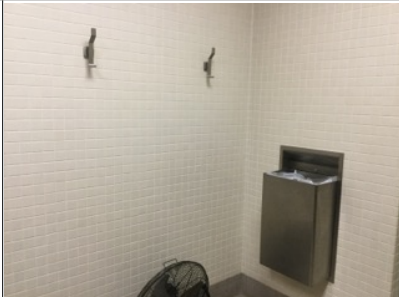
Operable Parts												
19	Men's Toilet Room	1		Operable Parts	Clothes Rod/Hooks

Reach < 15" or > 48"(forward/side approach)	63.5"	Lower at least one coat hook so that it is no higher than 48".	1	150	\$150

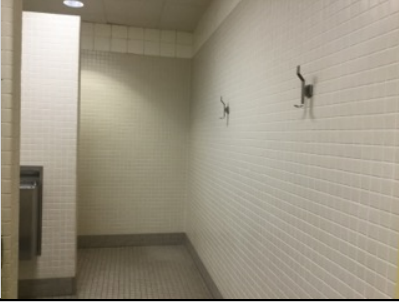
ID	Location	Floor	Room	Element	Type	Photo	Issues	Current Measure	Recommendations	Quantity	Price	Cost Estimation
20	Women's Toilet Room	1		Operable Parts	Clothes Rod/Hooks

Reach < 15" or > 48"(forward/side approach)	48"	Lower at least one coat hook so that it is no higher than 48".	1	150	\$150
Picnic Tables												
21	Accessible Parking to Picnic Table	Ext.		Picnic Tables	N/A

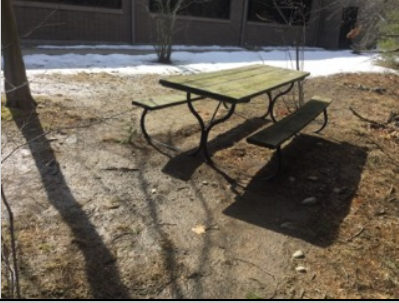
Toe or knee clearance at tables not provided Picnic table not on an accessible route	- - -	Provide at least 1 picnic table with toe and knee clearance. Ensure that the picnic table is connected to an accessible route. (Cost estimate for 6' long 4' wide asphalt route.)	1	1640	\$1640
Exterior Benches												
22	Main Entrance	Ext.		Exterior Benches	N/A

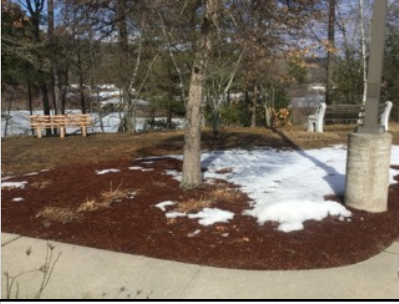
No accessible route to one bench in area	-	Provide an accessible route to one bench in this area. (Cost estimate for 10' long 4' wide asphalt route.)	1	400	\$400

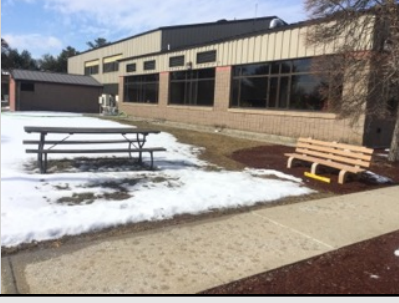
23	South Side of Building	Ext.		Exterior Benches	N/A

No accessible route to one bench in area	-	Provide an accessible route to the bench. (Cost estimate for 6' long 4' wide asphalt route.)	1	240	\$240
Toilet & Bathing Rooms

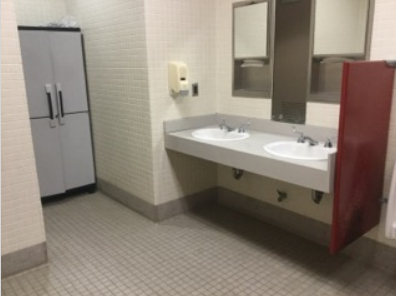
ID	Location	Floor	Room	Element	Type	Photo	Issues	Current Measure	Recommendations	Quantity	Price	Cost Estimation
Lavatory												
24	Men's Toilet Room	1		Lavatory	N/A

Plumbing underneath is exposed Dispensers not within reach range	- 54.25"	Insulate or otherwise configure pipes to prevent contact at one lavatory. Lower one paper towel dispenser to 44" above the finished floor.	1	445	\$445
25	Women's Toilet Room	1		Lavatory	N/A

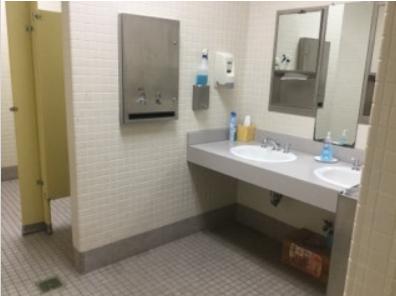
Plumbing underneath is exposed Dispensers not within reach range	- 55.25"	Insulate or otherwise configure pipes to prevent contact at one lavatory. Lower one paper towel dispenser to 44" above the finished floor.	1	445	\$445
Toilet Compartment												
26	Men's Toilet Room	1		Toilet Compartment	Accessible Compartment

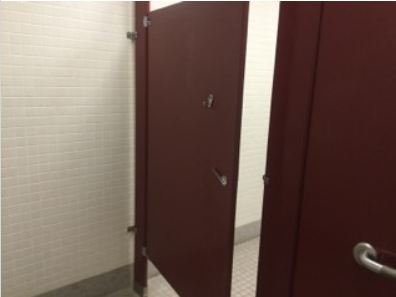
Door has non-compliant hardware Door has malfunctioning self-closing hinge	- -	Provide hardware that can be operable with one hand and not require tight grasping, pinching, or twisting of the wrist. Repair hinge.	1	70 Labor	\$70

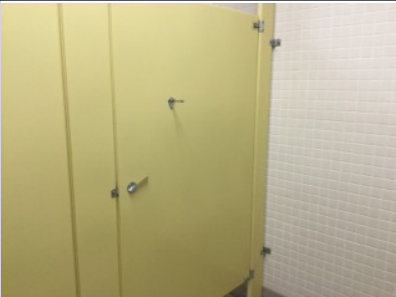
27	Women's Toilet Room	1		Toilet Compartment	Accessible Compartment

Door has non-compliant hardware Door has malfunctioning self-closing hinge	- -	Provide hardware that can be operable with one hand and not require tight grasping, pinching, or twisting of the wrist. Repair hinge.	1	70 Labor	\$70
28	Men's Toilet Room	1		Toilet Compartment	Accessible Compartment

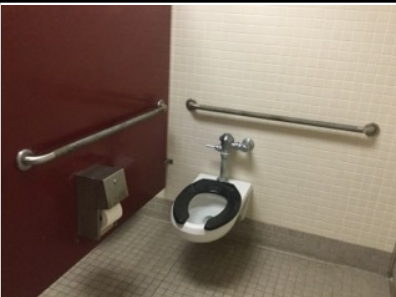
Flush control not on open side	-	Provide the flush control on the open side of the toilet (transfer side).	1	374	\$374

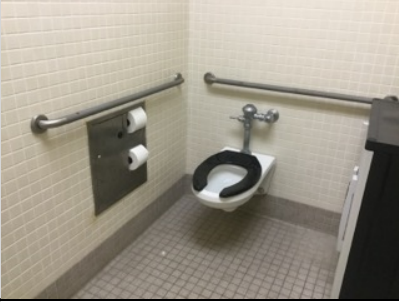
ID	Location	Floor	Room	Element	Type	Photo	Issues	Current Measure	Recommendations	Quantity	Price	Cost Estimation
29	Women's Toilet Room	1		Toilet Compartment	Accessible Compartment

Flush control not on open side	-	Provide the flush control on the open side of the toilet (transfer side).	1	374	\$374
30	Women's Toilet Room	1		Toilet Compartment	Accessible Compartment

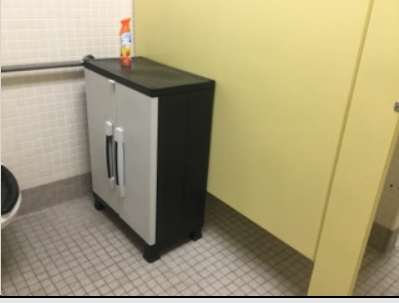
Clearance at toilet < 60" clear width	-	Provide a wheelchair accessible compartment that is 60" wide min.	1	6182	\$6182
Best Practice												
31	Exit 2 Exterior Route	Ext.			-

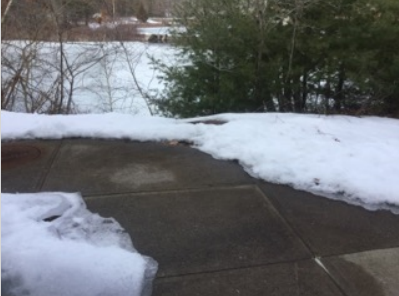
-	Recommend providing a guardrail alongside path.	1	-	\$0

- Recommend providing a guardrail alongside path from Exit 2 alongside the water at the water treatment facility.
