Animal Shelter

City of Attleboro ADA Transition Plan

April 2021

**City of Attleboro
Animal Shelter**

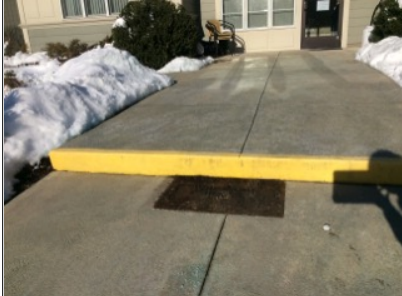
ID	Location	Floor	Room	Element	Type	Photo	Issues	Current Measure	Recommendations	Quantity	Price	Cost Estimation
Approach and Entrance												
Exterior Access Route												
1	Stair Entrance	Ext.		Exterior Access Route	Walkway

Mat not securely attached		Secure the mat.	1	Labor	\$0
2	Side Path to Dog Kennels (Volunteer Space)	Ext.		Exterior Access Route	Exterior

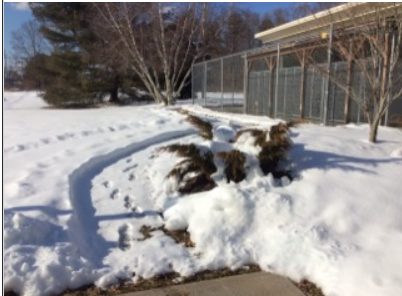
Accessible route not provided	-	Ensure an accessible route is provided. (Cost estimate for 20' long, 4' wide route.)	1	1280	\$1280
3	Side Path to Dog Kennels (Volunteer Space)	Ext.		Exterior Access Route	Exterior

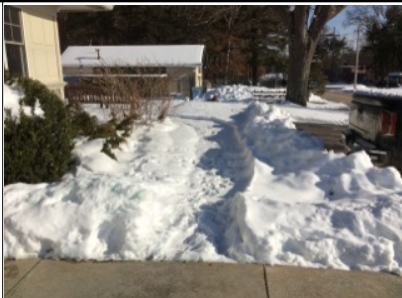
Accessible route not provided	-	Ensure an accessible route is provided. (Cost estimate for 20' long, 4' wide route.)	1	1280	\$1280
Off-Street Parking Lot or Garage												
4	Van Accessible Parking Space in Parking Lot	Ext.		Off-Street Parking Lot or Garage	Visitor

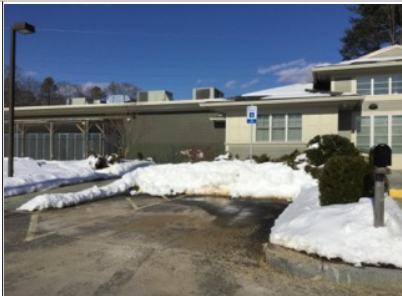
Van space < 132" or <96" wide Access aisle < 60" wide at car/van space	124" 56"	Provide a van accessible space that is at least 132" wide. Provide a marked access aisle that is at least 60" wide.	1	300	\$300

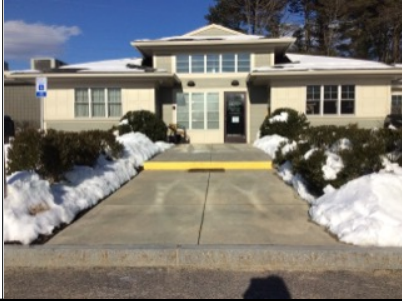
ID	Location	Floor	Room	Element	Type	Photo	Issues	Current Measure	Recommendations	Quantity	Price	Cost Estimation
Exterior Stair												
5	Stair Entrance	Ext.		Exterior Stair	N/A

Handrails not provided	-	Provide handrails on both sides of the step.	1	176	\$176
Entrance												
6	Main Entrance	Ext.		Entrance

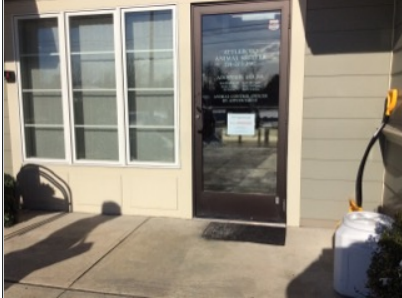
Mat not securely attached	-	Secure the mat.	1	Labor	\$0
Emergency Exit												
7	Lobby	1		Emergency Exit	N/A

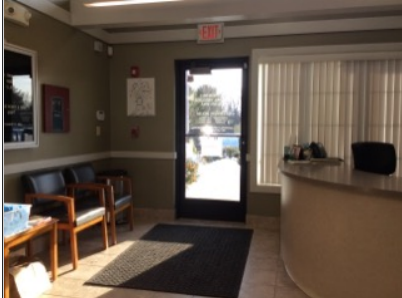
Tactile sign not provided at exit Illuminated Int. Symbol of Acc. not provided (MAAB)	- -	Provide tactile exit signs with raised characters and braille at exit doors. Mount signs between 48"- 60" above the finished floor located on the latch side of the door. Provide an illuminated sign with the International Symbol of Accessibility.	1	432	\$432
8	Rear Egress	1		Emergency Exit	N/A

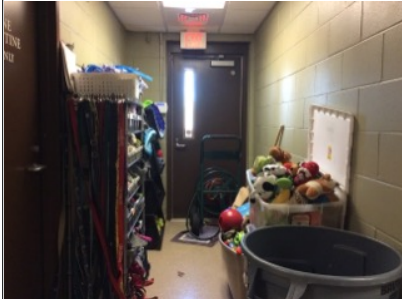
Directional sign to accessible emergency exit not provided	-	Provide a directional sign indicating the location of the nearest accessible emergency exit.	1	232	\$232

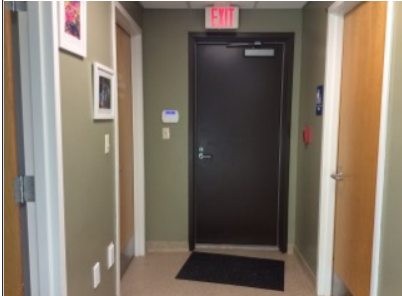
9	Egress by Toilet Rooms	1		Emergency Exit	N/A

Directional sign to accessible emergency exit not provided Mat not securely attached	- -	Provide a directional sign indicating the location of the nearest accessible emergency exit. Secure the mat.	1	232 Labor	\$232

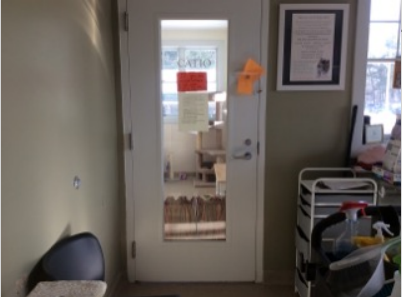
ID	Location	Floor	Room	Element	Type	Photo	Issues	Current Measure	Recommendations	Quantity	Price	Cost Estimation
Access to Goods and Services												
Doors, Doorways, & Gates												
10	Cat Adoption Room (Volunteer Space)	1		Doors, Doorways, & Gates	N/A

Maneuvering clearance(s) not provided	9.5"	Relocate the cart to provide 18" clear on the latch side of the door. Ensure that 60 is clear perpendicular to the door.	1	Labor	\$0
11	Cat Adoption Room (Volunteer Space)	1		Doors, Doorways, & Gates	N/A

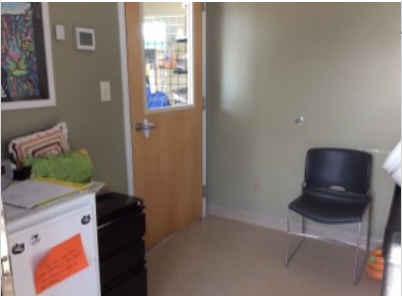
Maneuvering clearance(s) not provided	37.5"	Relocate chair to ensure that 60 is clear perpendicular to the door.	1	Labor	\$0
12	Women's Toilet Room	1		Doors, Doorways, & Gates	Toilet Room

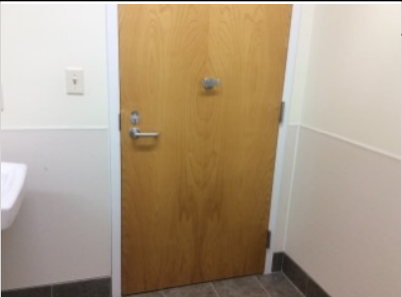
Maneuvering clearance(s) not provided	16"	Provide an automatic door opener.	1	3060	\$3060
13	Men's Toilet Room	1		Doors, Doorways, & Gates	Toilet Room

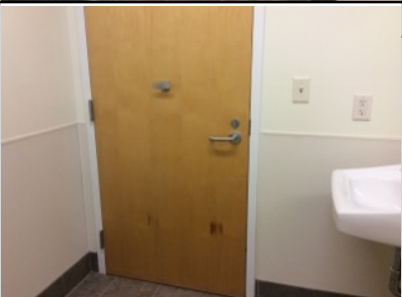
Maneuvering clearance(s) not provided	15.5"	Provide an automatic door opener.	1	3060	\$3060

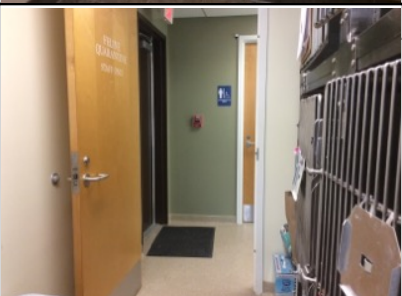
14	Feline Quarantine (Volunteer Space)	1		Doors, Doorways, & Gates	N/A

Maneuvering clearance(s) not provided	11.25"	Relocate cage to provide 18" clear on the latch side of the door that is 60" deep.	1	Labor	\$0

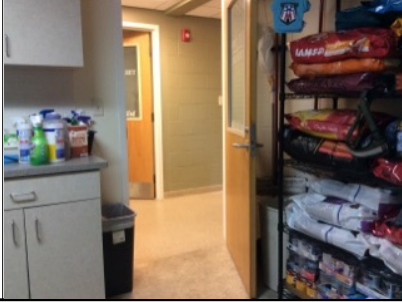
ID	Location	Floor	Room	Element	Type	Photo	Issues	Current Measure	Recommendations	Quantity	Price	Cost Estimation
15	Food Prep and Laundry (Volunteer Space)	1		Doors, Doorways, & Gates	Circulation

Maneuvering clearance(s) not provided	12"	Provide an automatic door opener. Relocate shelf so that door can open fully to 90 degrees.	1	3060 Labor	\$3060
Signage												
16	Cat Adoption Room	1		Signage	Designation

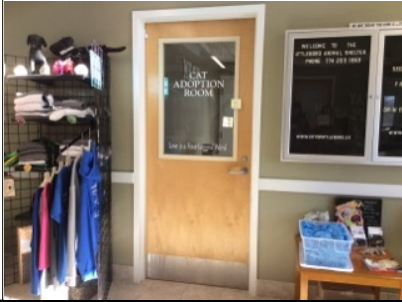
Raised characters not provided on sign Braille not provided on sign Sign not located on the latch side of the door Non glare finish and contrast not provided on sign	- - - -	Provide text with raised characters duplicated in braille on sign. Locate sign at permanent rooms alongside the door on the latch side. Install a sign with a non-glare finish with characters that have a high contrast to the background.	1	232	\$232
17	Feline Quarantine (Volunteer Space)	1		Signage	Designation

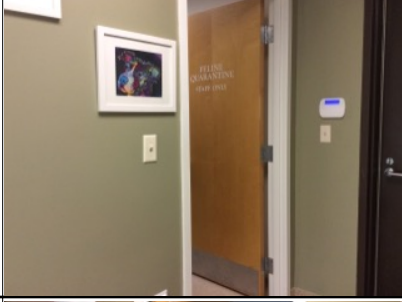
Raised characters not provided on sign Braille not provided on sign Sign not located on the latch side of the door	- - -	Provide text with raised characters duplicated in braille on sign. Locate sign at permanent rooms alongside the door on the latch side.	1	232	\$232

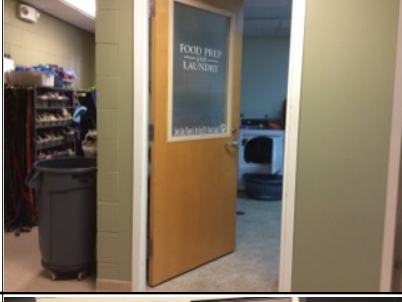
18	Food Prep and Laundry (Volunteer Space)	1		Signage	Designation

Raised characters not provided on sign Braille not provided on sign Sign not located on the latch side of the door Non glare finish and contrast not provided on sign	- - - -	Provide text with raised characters duplicated in braille on sign. Locate sign at permanent rooms alongside the door on the latch side. Install a sign with a non-glare finish with characters that have a high contrast to the background.	1	232	\$232
19	Main Entrance	Ext.		Signage	Informational

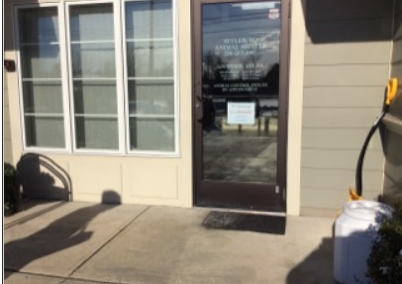
Non glare finish and contrast not provided on sign	-	Install a sign with a non-glare finish with characters that have a high contrast to the background.	1	232	\$232

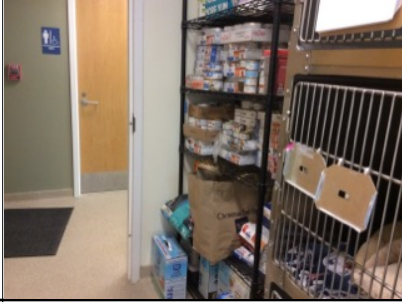
ID	Location	Floor	Room	Element	Type	Photo	Issues	Current Measure	Recommendations	Quantity	Price	Cost Estimation
Operable Parts												
20	Feline Quarantine (Volunteer Space)	1		Operable Parts	Other

Reach < 15" or > 48"(forward/side approach)	64"	If a volunteer cannot reach something on the top shelf have a staff person do it.	1	-	\$0
21	Feline Quarantine (Volunteer Space)	1		Operable Parts	Other

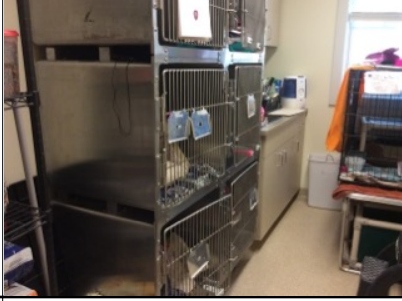
Reach < 15" or > 48"(forward/side approach)	11.25"	If a volunteer cannot open the lock have a staff person do it.	1	-	\$0
22	Food Prep and Laundry (Volunteer Space)	1		Operable Parts	Other

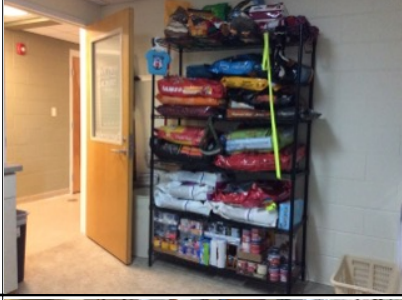
Reach < 15" or > 48"(forward/side approach)	74.5"	If a volunteer cannot reach the top shelf have a staff person do it.	1	-	\$0
23	Cat Adoption Room (Volunteer Space)	1		Operable Parts	Other

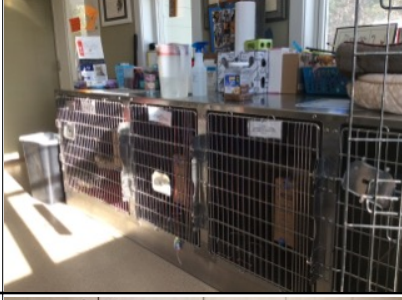
Reach < 15" or > 48"(forward/side approach) Not operable with a closed fist	11" -	If a volunteer cannot open the lock have a staff person do it.	4	-	\$0

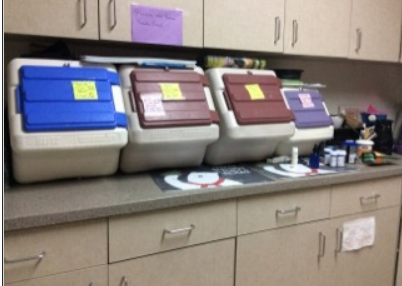
24	Food Prep and Laundry Food Bins (Volunteer Space)	1		Operable Parts	Equipment

Reach < 15" or > 48"(forward/side approach) Not operable with a closed fist	49.5" -	If a volunteer cannot open the food bins have a staff person do it.	1	-	\$0

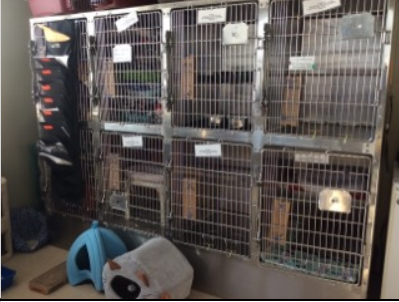
ID	Location	Floor	Room	Element	Type	Photo	Issues	Current Measure	Recommendations	Quantity	Price	Cost Estimation
25	Cat Adoption Room (Volunteer Space)	1		Operable Parts	Other

Not operable with a closed fist	-	If a volunteer cannot open the lock have a staff person do it.	8	-	\$0
26	Feline Quarantine (Volunteer Space)	1		Operable Parts	Other

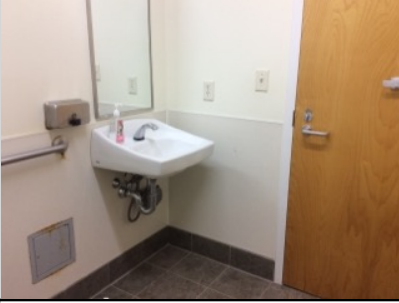
Plumbing underneath is exposed	-	Insulate or otherwise configure pipes to prevent contact at lavatory.	1	92	\$92
28	Men's Toilet Room	1		Lavatory	N/A

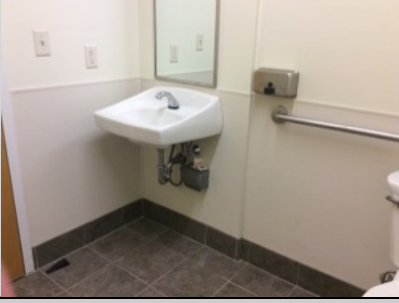
Plumbing underneath is exposed	-	Insulate or otherwise configure pipes to prevent contact at lavatory.	1	92	\$92
Dispensers												
29	Women's Toilet Room	1		Dispensers	Paper Towel Dispenser

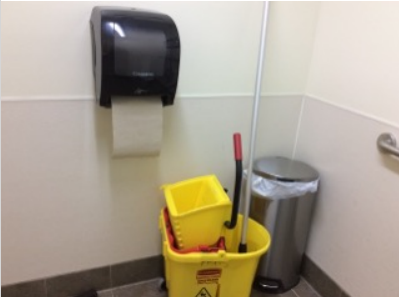
Dispenser acts as a protruding object	9"	Relocate dispenser out of the circulation path.	1	256	\$256

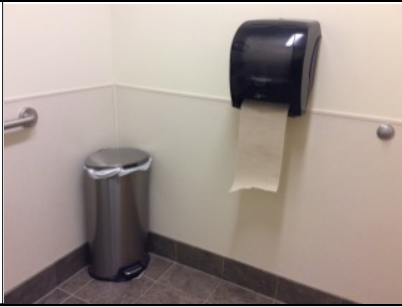
ID	Location	Floor	Room	Element	Type	Photo	Issues	Current Measure	Recommendations	Quantity	Price	Cost Estimation
30	Men's Toilet Room	1		Dispensers	Paper Towel Dispenser

Dispenser acts as a protruding object	9"	Relocate dispenser out of the circulation path.	1	256	\$256
Additional Access												
Sink												
31	Food Prep and Laundry (Volunteer Space)	1		Sink	Kitchenette

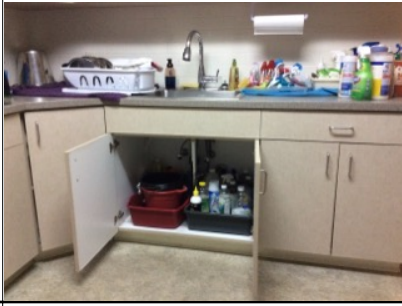
Toe and knee clearances not provided Rim or counter > 34" Exposed plumbing underneath sink Dispenser not within reach range	- 36" - 52"	Ensure there is a 27" knee clearance positioned for a forward approach. Relocate sink with the front of the rim or counter no higher than 34". Insulate or otherwise configure pipes at sink. Relocate dispenser 48" max. above the finished floor or ground.	1	3442	\$3442
32	Feline Quarantine (Volunteer Space)	1		Sink	Other

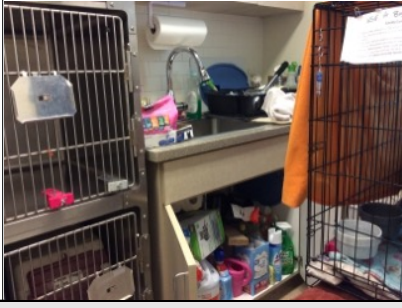
Rim or counter > 34" Dispenser not within reach range Clear floor space not provided at sink Toe and knee clearances not provided	18" - 36" 53.75"	Provide a 30" by 48" clear floor space positioned for a forward approach - relocate cage. Ensure there is a 27" knee clearance positioned for a forward approach to the sink. Relocate sink with the front of the rim or counter no higher than 34". Relocate paper towel dispenser 48" max. above the finished floor or ground.	1	3350	\$3350

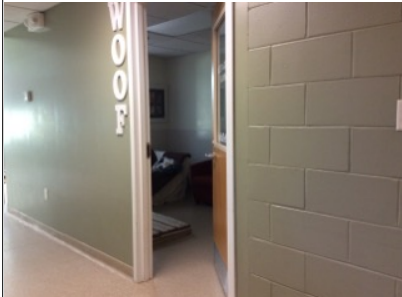
Best Practice												
33	Meet and Greet Room for Dogs	1		-	-

-	Recommend providing accessible designation signage mounted on the latch side of the door at permanent rooms that lack designation signage.	1	-	\$0
